City of Fayetteville Staff Review Form

SUBJECT: **Repair of Cyclo-Blowers at the West Side Treatment Facility**

Blower Repair Quote / Evaluation Report

Blower Model: Cycloblower 9CDL18
Serial Number: S257153A18 **Last Repair Date:** 1/25/2018

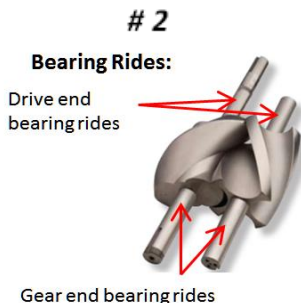
Drive Rotor Evaluation Results:

Drive Rotor OD: (# 1)	Within factory allowable tolerances.
Drive Bearing Ride: (# 2)	Within factory allowable tolerances / specifications .
Gear End Bearing Ride: (# 2)	Within factory allowable tolerances / specifications .
Rotor End Condition: (# 3)	Within factory allowable tolerances / specifications .

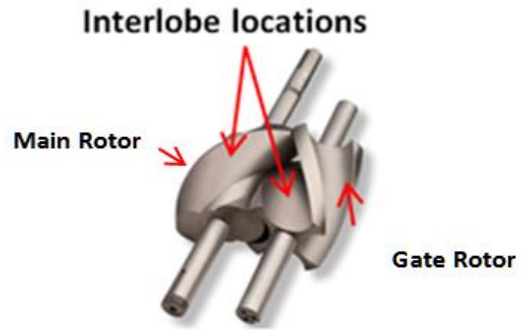
Interlobe:

Interlobe condition: Within factory allowable tolerances / specifications .

Interlobe clearances (rotor to rotor clearance) are the internal sealing tolerances and are critical to overall blower performance. Interlobe damage cannot be repaired due to the rotor body profile / design. Excessive Interlobe clearances will allow air to slip in the housing chamber which causes a loss of performance and potentially lead to overheating.

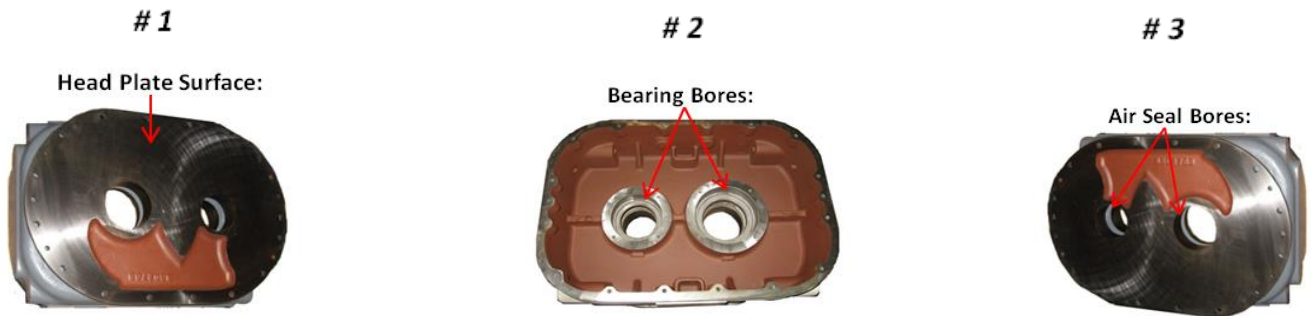
Discharge End Head Plate:

Surface Condition: (# 1) Within factory allowable tolerances / specifications .

Bearing Bore Condition: (# 2) The head-plate bearing bore oversized due to the bearings failure and required machine work for repair .

Air Seal Bore Condition: (# 3) Within factory allowable tolerances / specifications .

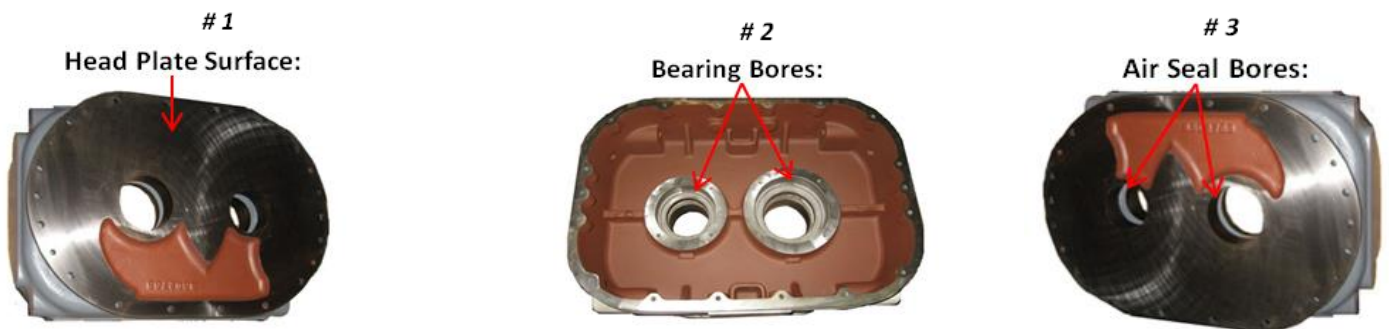
Suction End Head Plate:

Surface Condition: Within factory allowable tolerances / specifications .

Bearing Bore Condition: Damaged / oversized due to a bearing failure and will require re-sleeving / machining for repair.

Air Seal Bore Condition: Within factory allowable tolerances / specifications .

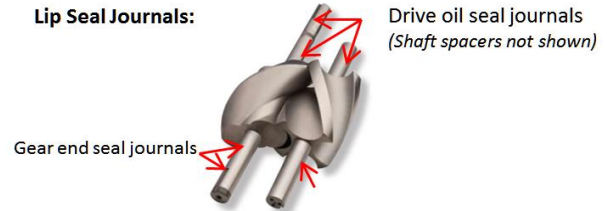
Internal Seal Journals: Damaged due to grooves created by the old lip seals and will require repair with Speedie sleeves.

External Seal Journals: Damaged due to grooves created by the old lip seals and will require repair with Speedie sleeves.

A seal journal is the area where the lip seal contacts the drive shaft. The seal journal condition is crucial in obtaining proper sealing. Over long periods of operation, lip seals can cut a groove into the steel shaft which creates a unacceptable sealing surface. Damaged seal journals typically require sleeving for repair to insure proper sealing.

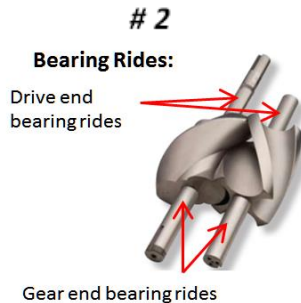
Drive Rotor Evaluation Results:

Drive Rotor OD: (# 1)	Within factory allowable tolerances.
Drive Bearing Ride: (# 2)	Within factory allowable tolerances / specifications .
Gear End Bearing Ride: (# 2)	Within factory allowable tolerances / specifications .
Rotor End Condition: (# 3)	Within factory allowable tolerances / specifications .

Comments: The rotor body surface has abrasions due to the rust contamination which will be removed with additional polishing.

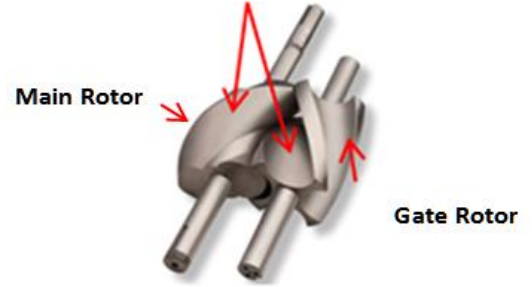
Interlobe locations

Interlobe condition: Within factory allowable tolerances / specifications .

Interlobe clearances (rotor to rotor clearance) are the internal sealing tolerances and are critical to overall blower performance. Interlobe damage cannot be repaired due to the rotor body profile / design. Excessive Interlobe clearances will allow air to slip in the housing chamber which causes a loss of performance and potentially lead to overheating.

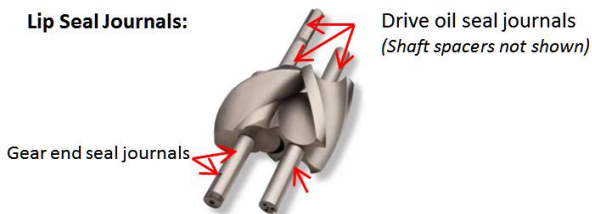
Internal Seal Journals: Damaged due to grooves created by the old lip seals and will be repaired with new rotor shaft sleeves.

External Seal Journals: Damaged due to grooves created by the old lip seals and will be repaired with new rotor shaft sleeves.

A seal journal is the area where the lip seal contacts the drive shaft. The seal journal condition is crucial in obtaining proper sealing. Over long periods of operation, lip seals can cut a groove into the steel shaft which creates a unacceptable sealing surface. Damaged seal journals typically require sleeving for repair to insure proper sealing.
