City of Fayetteville Staff Review Form

SUBJECT: ANX 2020-000001: Annexation (3435 E. ZION RD./BURGE, 100/139):
Submitted by WATKINS LAW OFFICE for property located at 3435 E. ZION RD.
The property is in the FAYETTEVILLE PLANNING AREA and contains
approximately 59.00 acres. The request is to annex the property into the City Limits
of Fayetteville with the zoning of R-A, RESIDENTIAL AGRICULTURE.

The USDA Natural Resource Conservation Service (NRCS) awarded the Watershed Conservation Resource Center (WCRC) a grant to conduct an inventory of the riparian and streambank conditions for 20 miles of Clear Creek and select tributaries. The inventory included the main stem of Clear Creek and the tributaries above the Lake Fayetteville dam and the Skull Creek tributary. A map of the entire project area is shown in Figure 1-1. The project objectives were to:

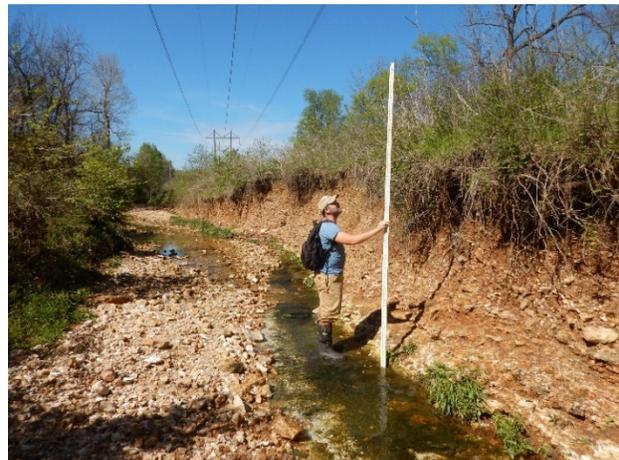
- 1) Erosion Potential was evaluated using the Bank Erosion Hazard Index (BEHI) method which includes the following factors
 - a. Root Depth
 - b. Root Density
 - c. Bank Height Ratio
 - d. Bank Angle
 - e. Surface Protection
 - f. Bank Material
 - g. Bank Stratification
- 2) Near Bank Shear Stress (NBSS) was Evaluated
- 3) Bank height and length was measured
- 4) The soil horizons were categorized and weighted
- 5) Photo of each streambank was taken

Figure 2-1. BEHI and NBSS Data Being Categorized on Clear Creek

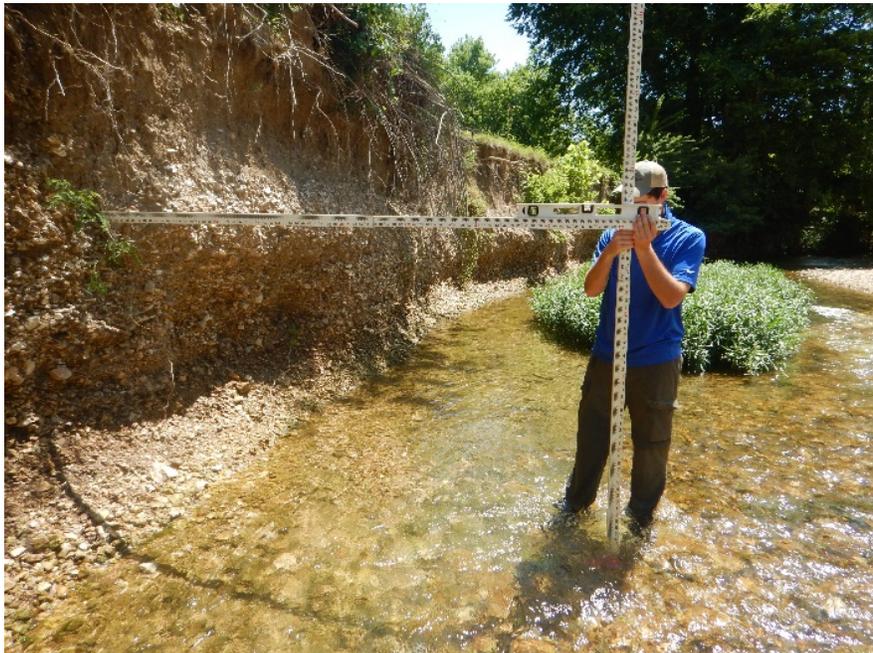
Toe pin monitoring sites were created at each selected stream bank by installing a permanent survey monument by hammering a 2' long piece of rebar into the toe of the bank or by drilling in a concrete anchor and ratcheting in a bolt into bedrock sites. A leveling survey rod is placed vertically on top of the toe pin or bolt and another is held level horizontally from the profile of the bank (Figure 2-2). Vertical and horizontal changes in slope for the bank profile are recorded from the permanent monument.

Figure 2-2. Toe Pin Monitoring Conducted on Clear Creek

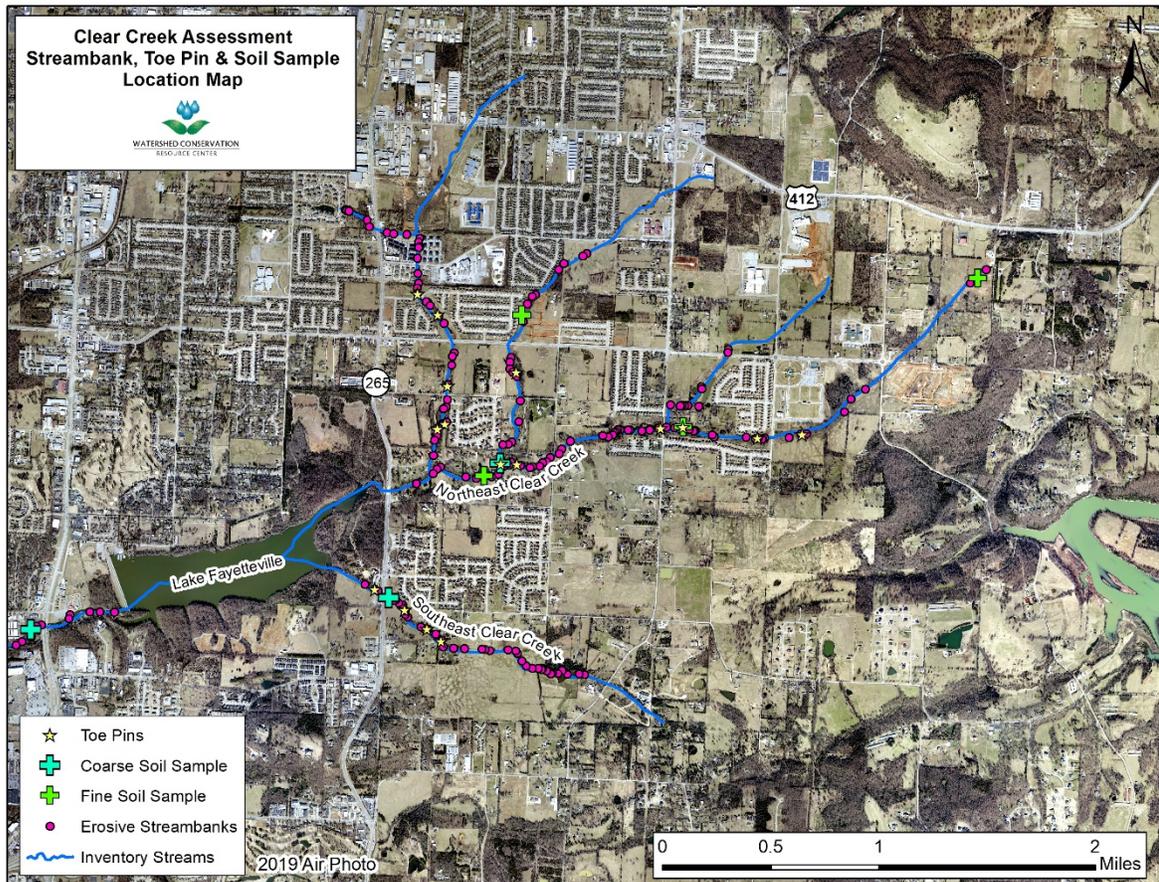
Figure 2-3. Eastern Section of the Clear Creek Watershed. This figure shows the streambank locations accounted in the inventory, toe pin locations and soil samples

Samples of the streambank materials (Figure 2-6) were collected at twenty-two different banks throughout the watershed and their locations are shown in Figures 2-3 - 2-5. Sampling sites were selected to provide representation of the bank materials typically found within the study area. Of the samples collected for analysis, twelve coarse bank materials and ten fine bank materials were obtained. A coarse soil sample is generally composed of a mixture of gravel and/or cobble, sand, and soil while fine soil samples consisted only of sand and soils of various textures. Coarse samples were collected using techniques based on published methods (Brye, 2004). This includes the use

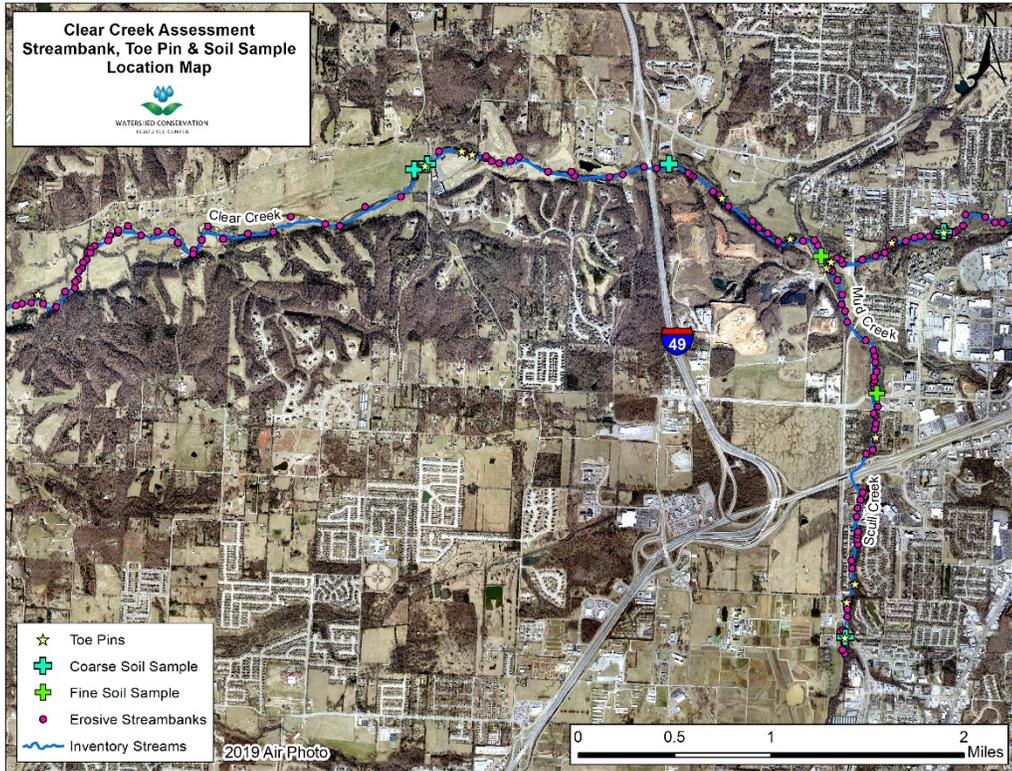
Figure 2-4. Central Section of the Clear Creek Watershed. This figure shows the streambank locations accounted in the inventory, toe pin locations, and soil samples

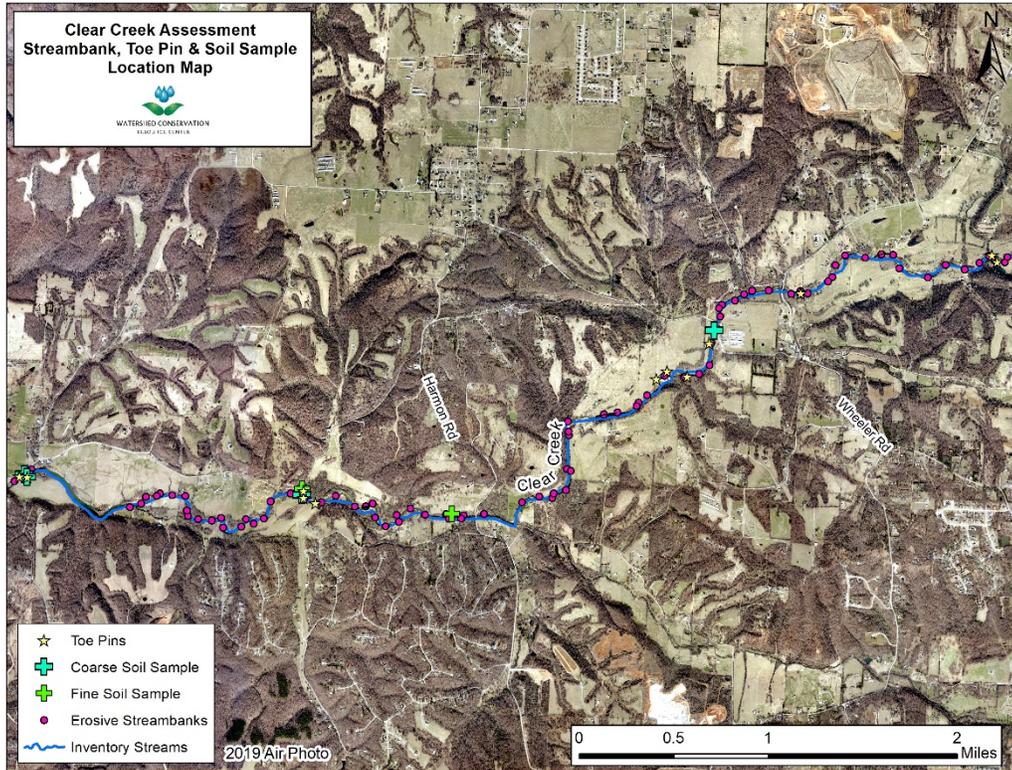
Figure 2-5. Western Section of the Clear Creek Watershed. This figure shows the streambank locations accounted in the inventory, toe pin locations, and soil samples

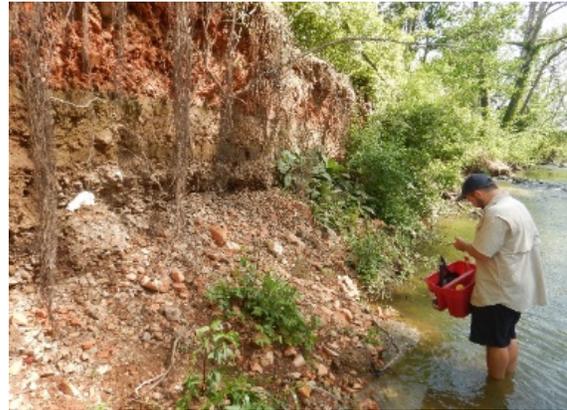
Figure 2-6. Coarse Soil Sampling on Clear Creek

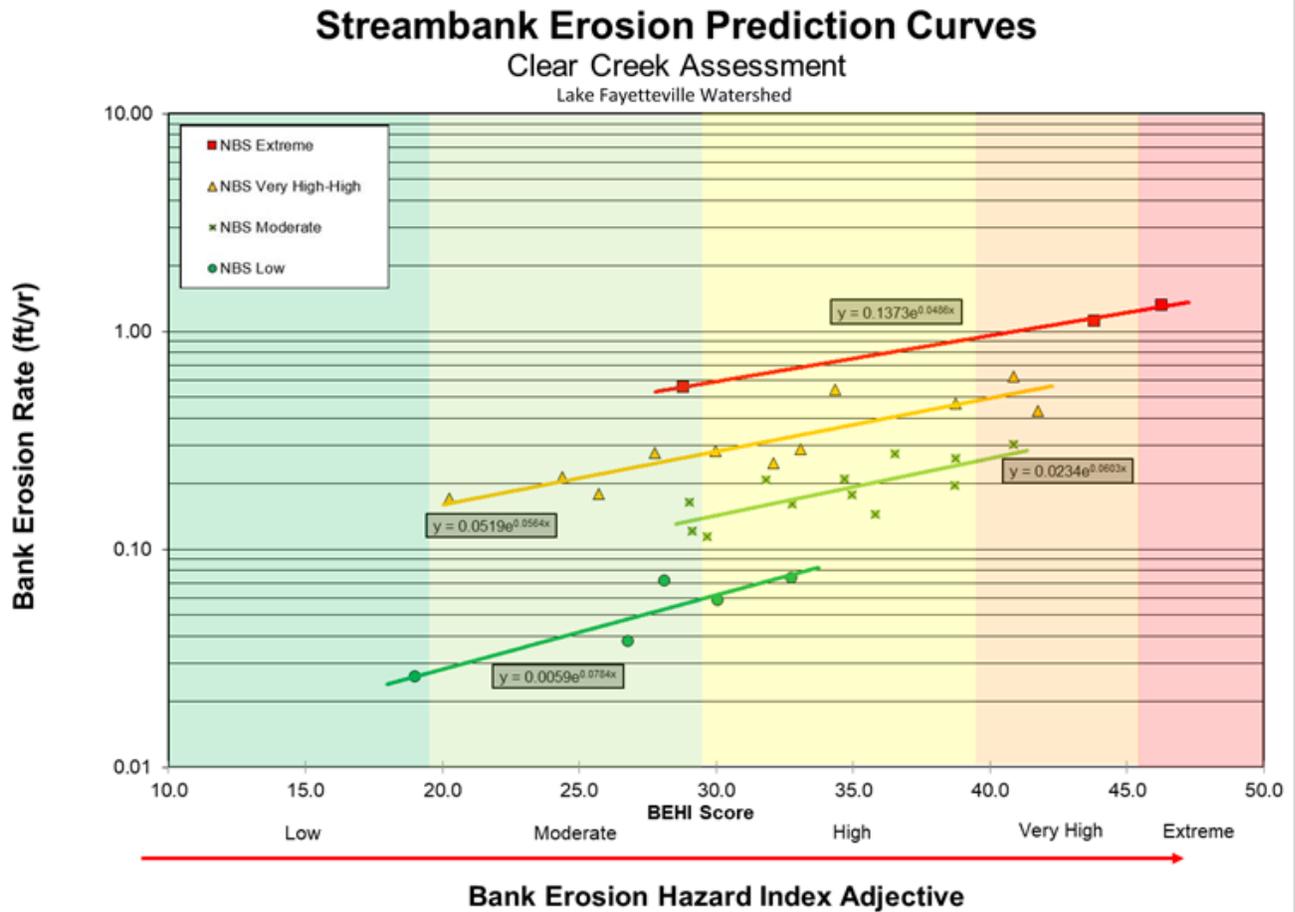
Figure 2-7. BEHI Plotted against Bank Erosion for Four NBSS Cases for Streambanks for use in the Lake Fayetteville Watershed only.

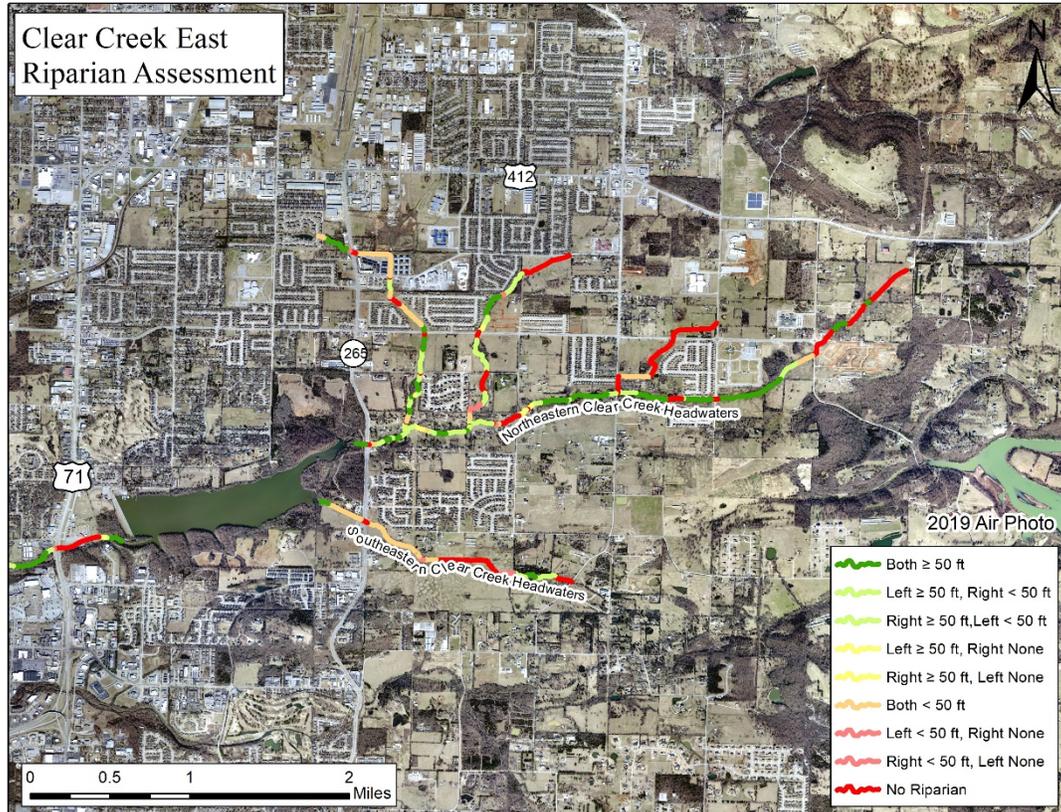
Figure 2- 12. Riparian Conditions for the Clear Creek Watershed in Lake Fayetteville

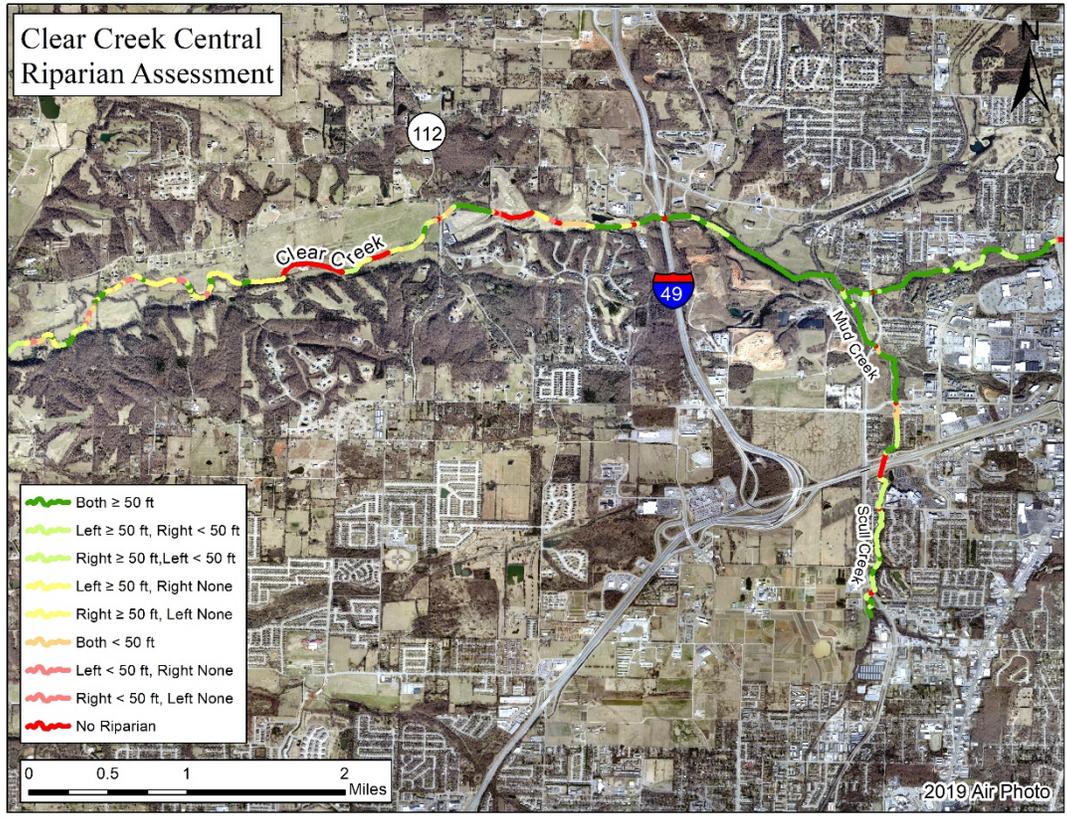
Figure 2-13. Riparian Conditions for the Clear Creek Watershed in the Central Section

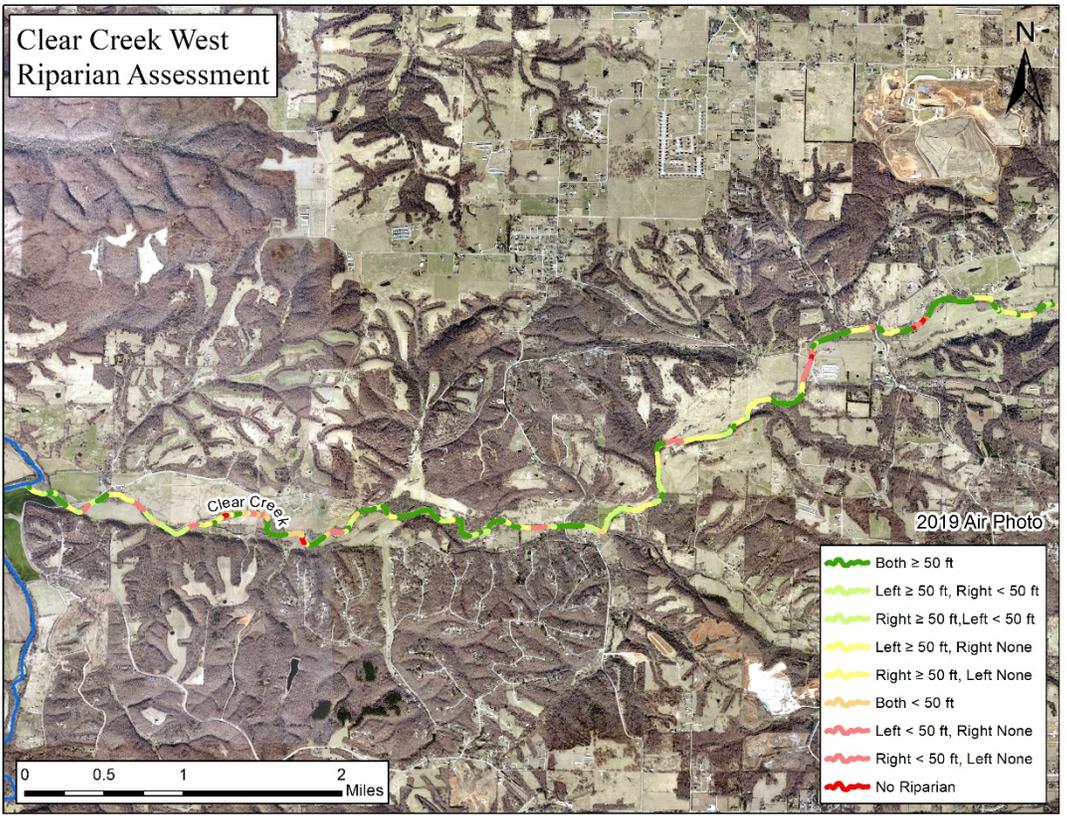
Figure 2-14. Riparian Conditions for the Clear Creek Watershed in the Western Section

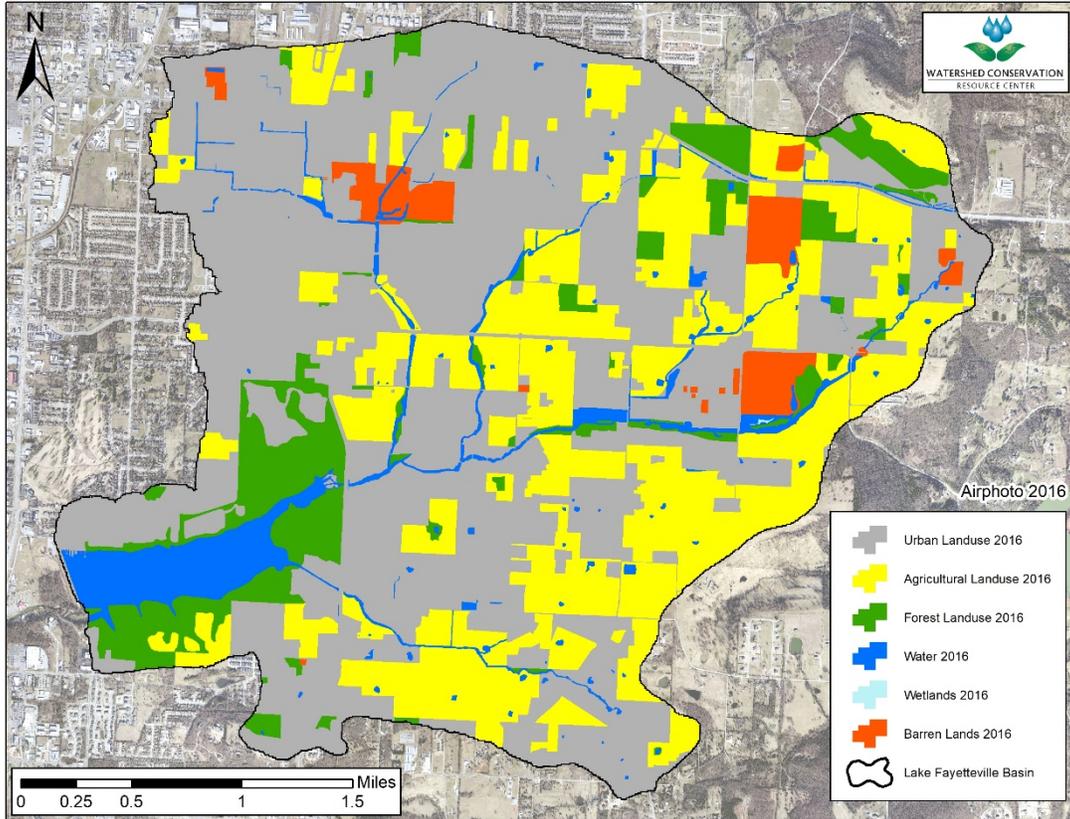
Figure 3-2. Level I Analysis Completed for the Lake Fayetteville Watershed in 2016

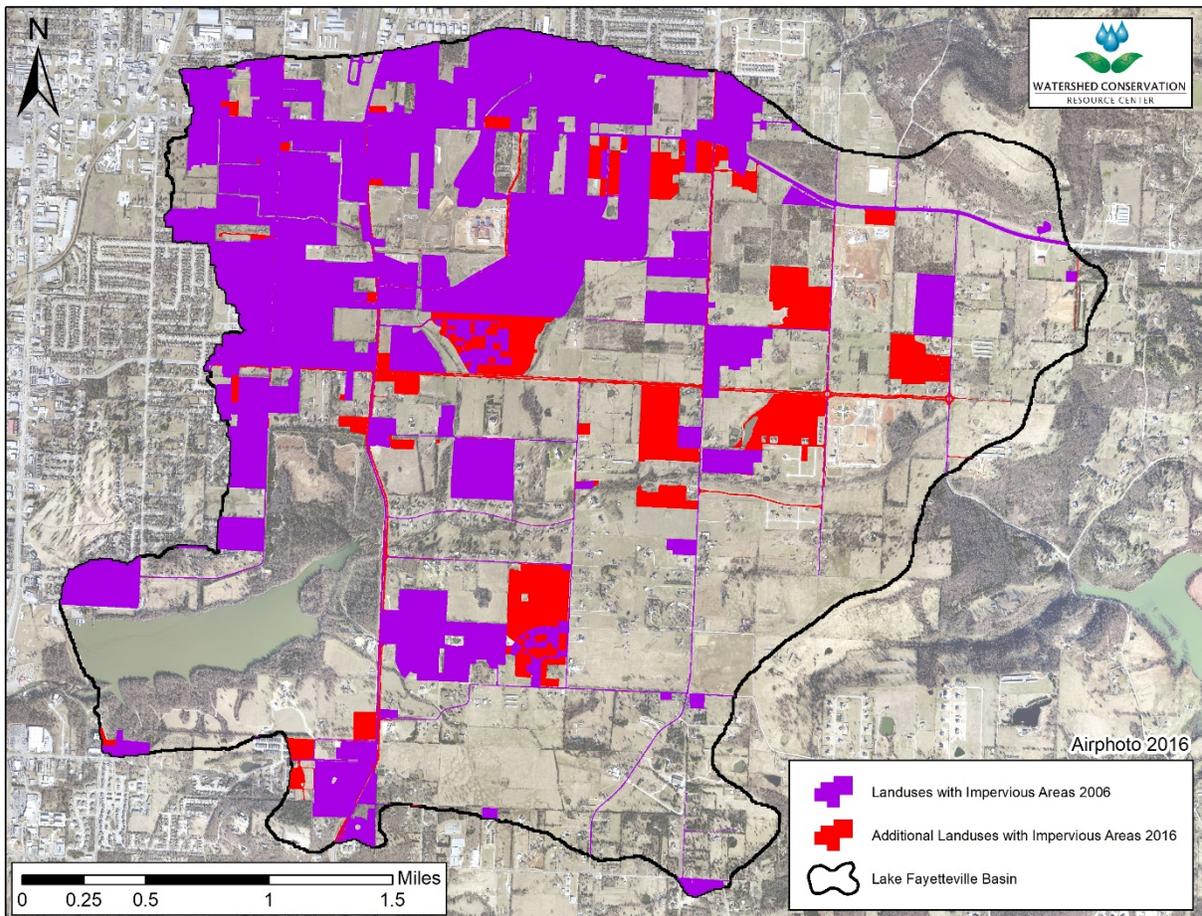
The Center for Watershed Protection has developed a tool for predicting the effects of the amount of impervious features within a watershed to the streams within them. This is known as the Impervious Cover Model (Schuler 2005). This model separates impact on streams into four categories of Impervious Cover (IC) 1) Sensitive (0% - 10% IC) 2) Impacted (10% - 25% IC) 3) Non-supporting (25% - 60% IC) 4) Urban Drainage (>60% IC). The results of the analysis showed that in 2006, 13% of the watershed was impervious and in 2016, the impervious surface increased to 16% of the watershed. Both of these percentages fall into the impacted category. Though the categorization hasn't changed since 2006, it has increased. Streams that are impacted suffer from degraded water quality, loss of riparian cover, and channel enlargement. However, these streams are generally good candidates for restoration as there is significant undeveloped land use where BMPs can be implemented to mitigate and restore loss of groundwater infiltration within the watershed.

Figure 3-3. Land Use Types Identifying Areas with Imperviousness for 2006 and Additional Areas with Imperviousness in 2016.

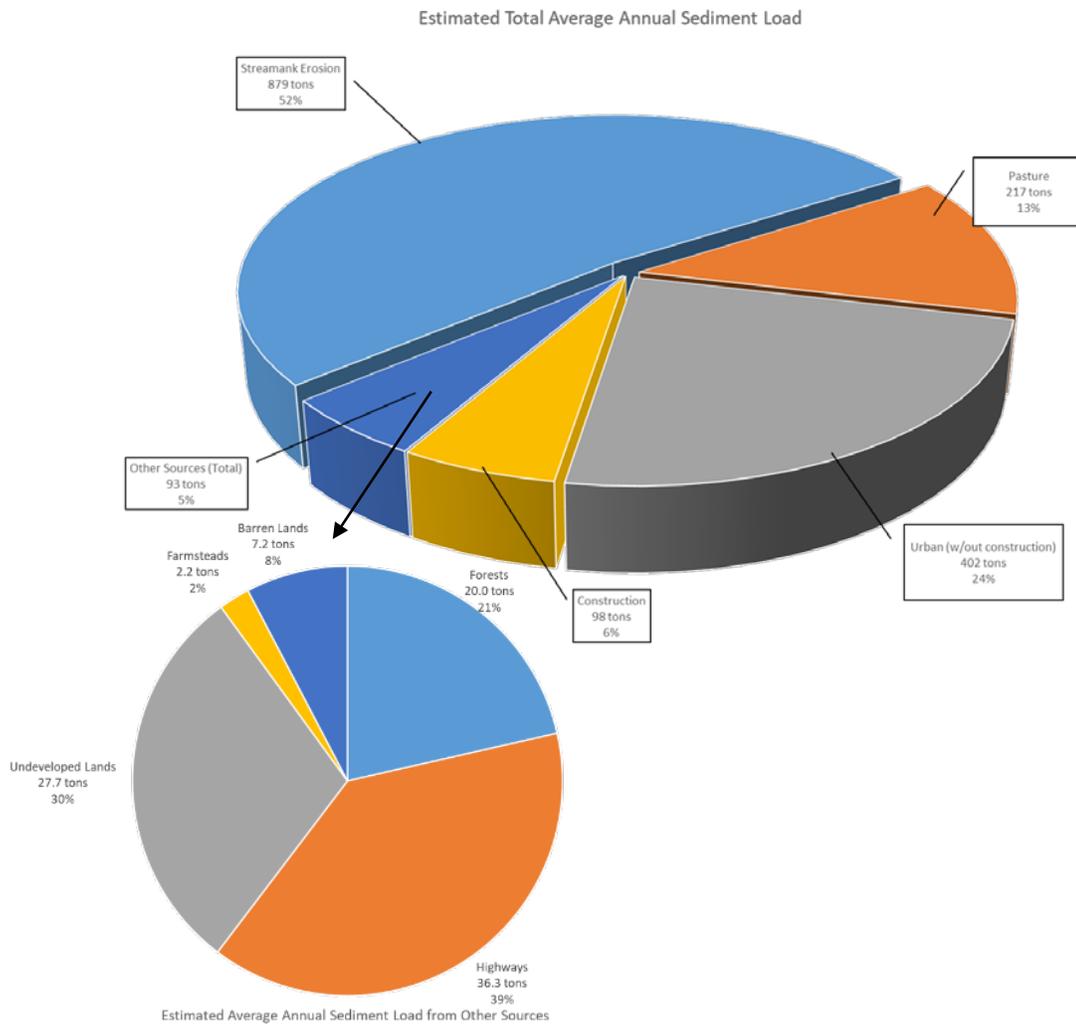
Figure 3-6. Sediment Sources in the Lake Fayetteville Watershed

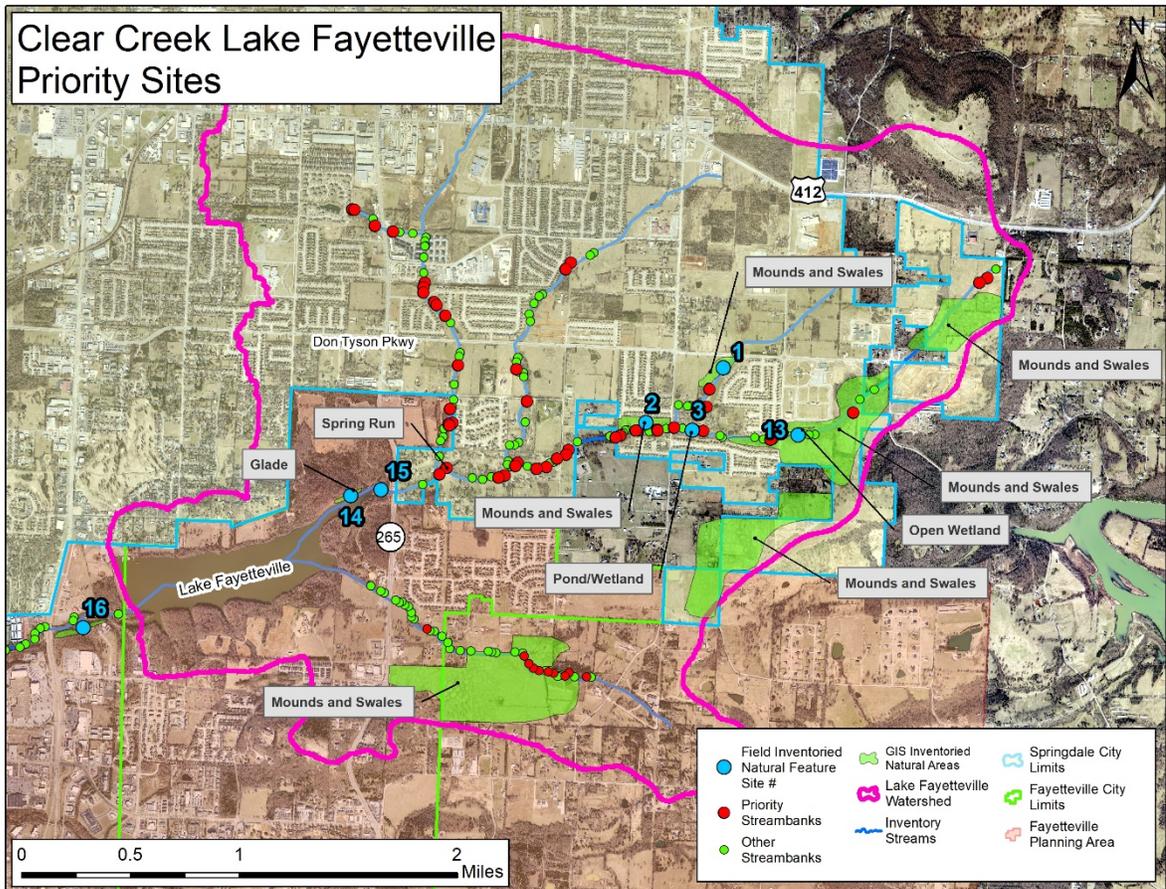
Figure 6-1. Priority Streambanks Overlaid with Natural Features Developed in the Ecological Analysis in the Lake Fayetteville watershed.

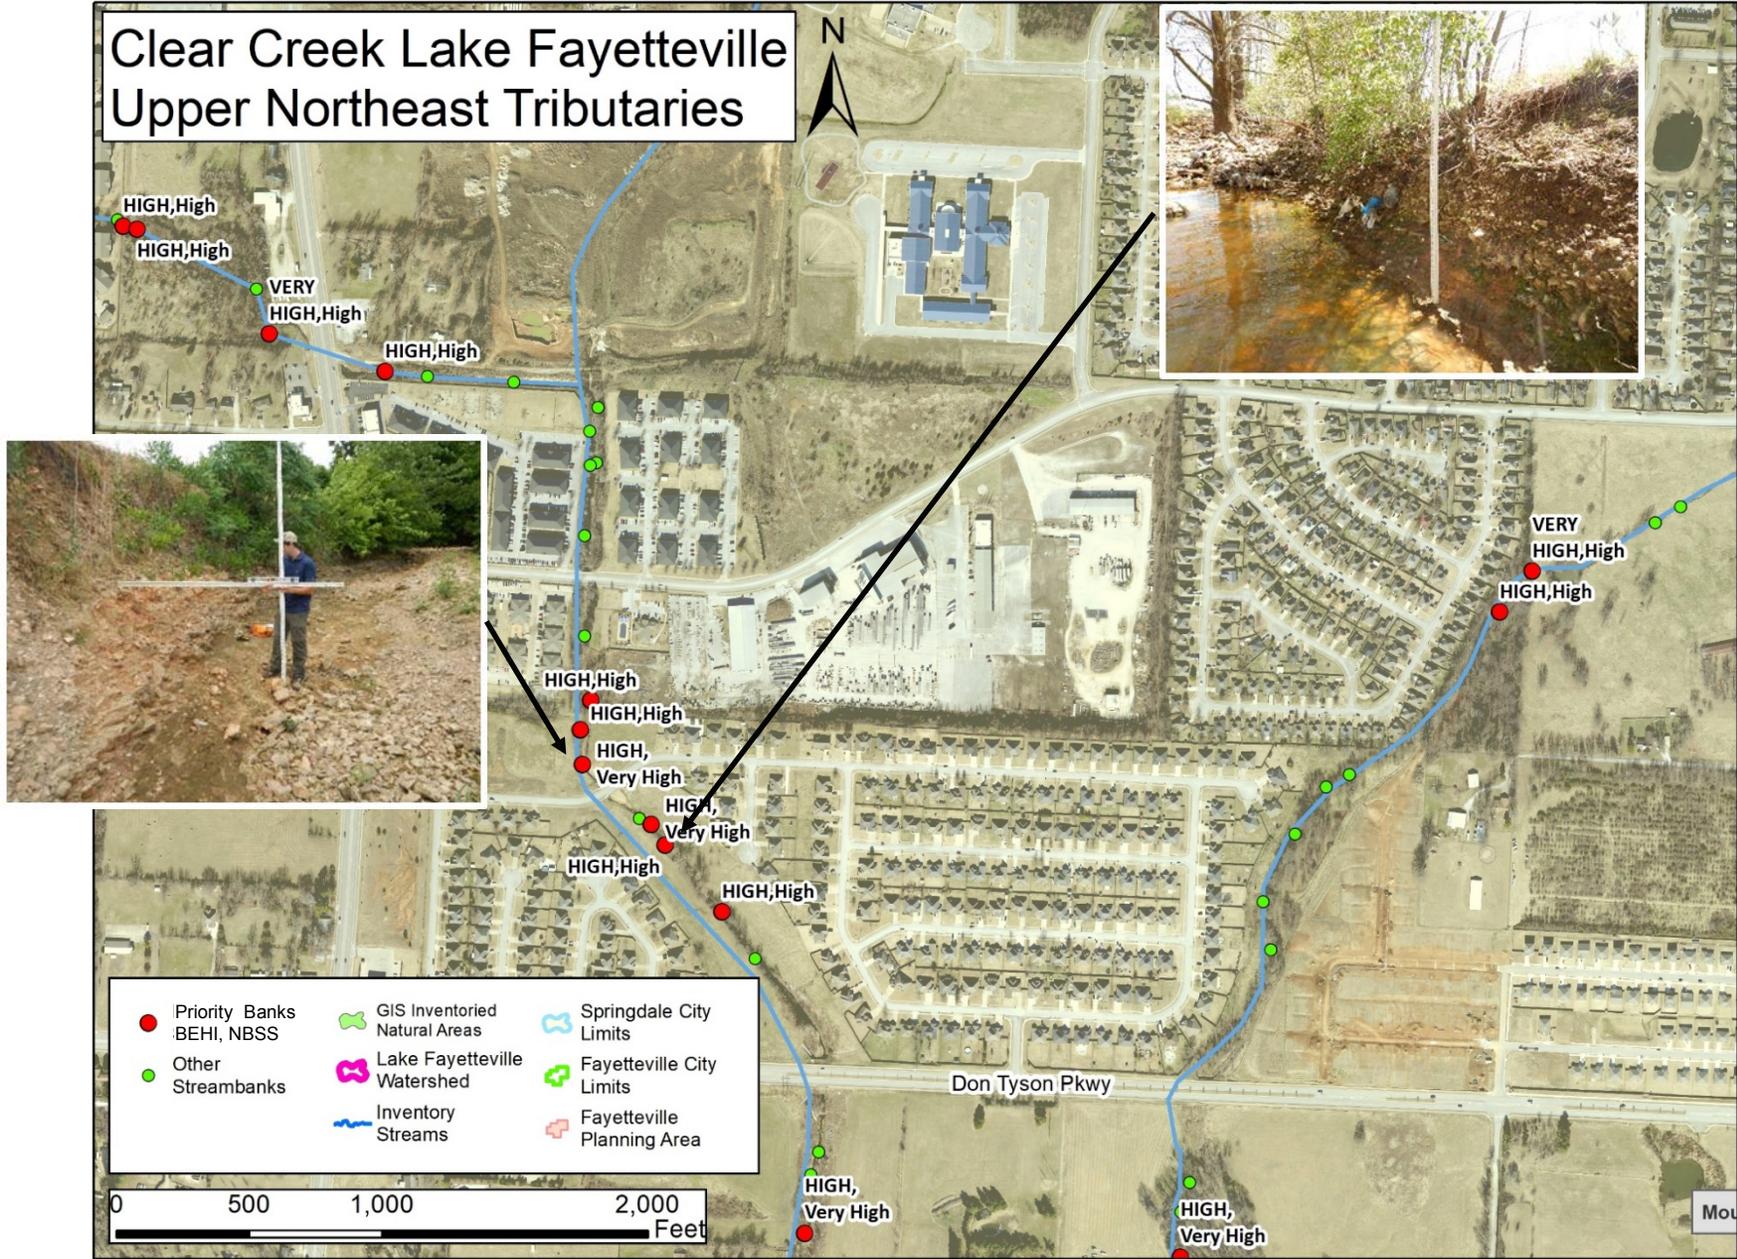
Figure 6-3. Lake Fayetteville Watershed – Priority Sites for Restoration and/or Conservation in the Upper Northeast Tributaries

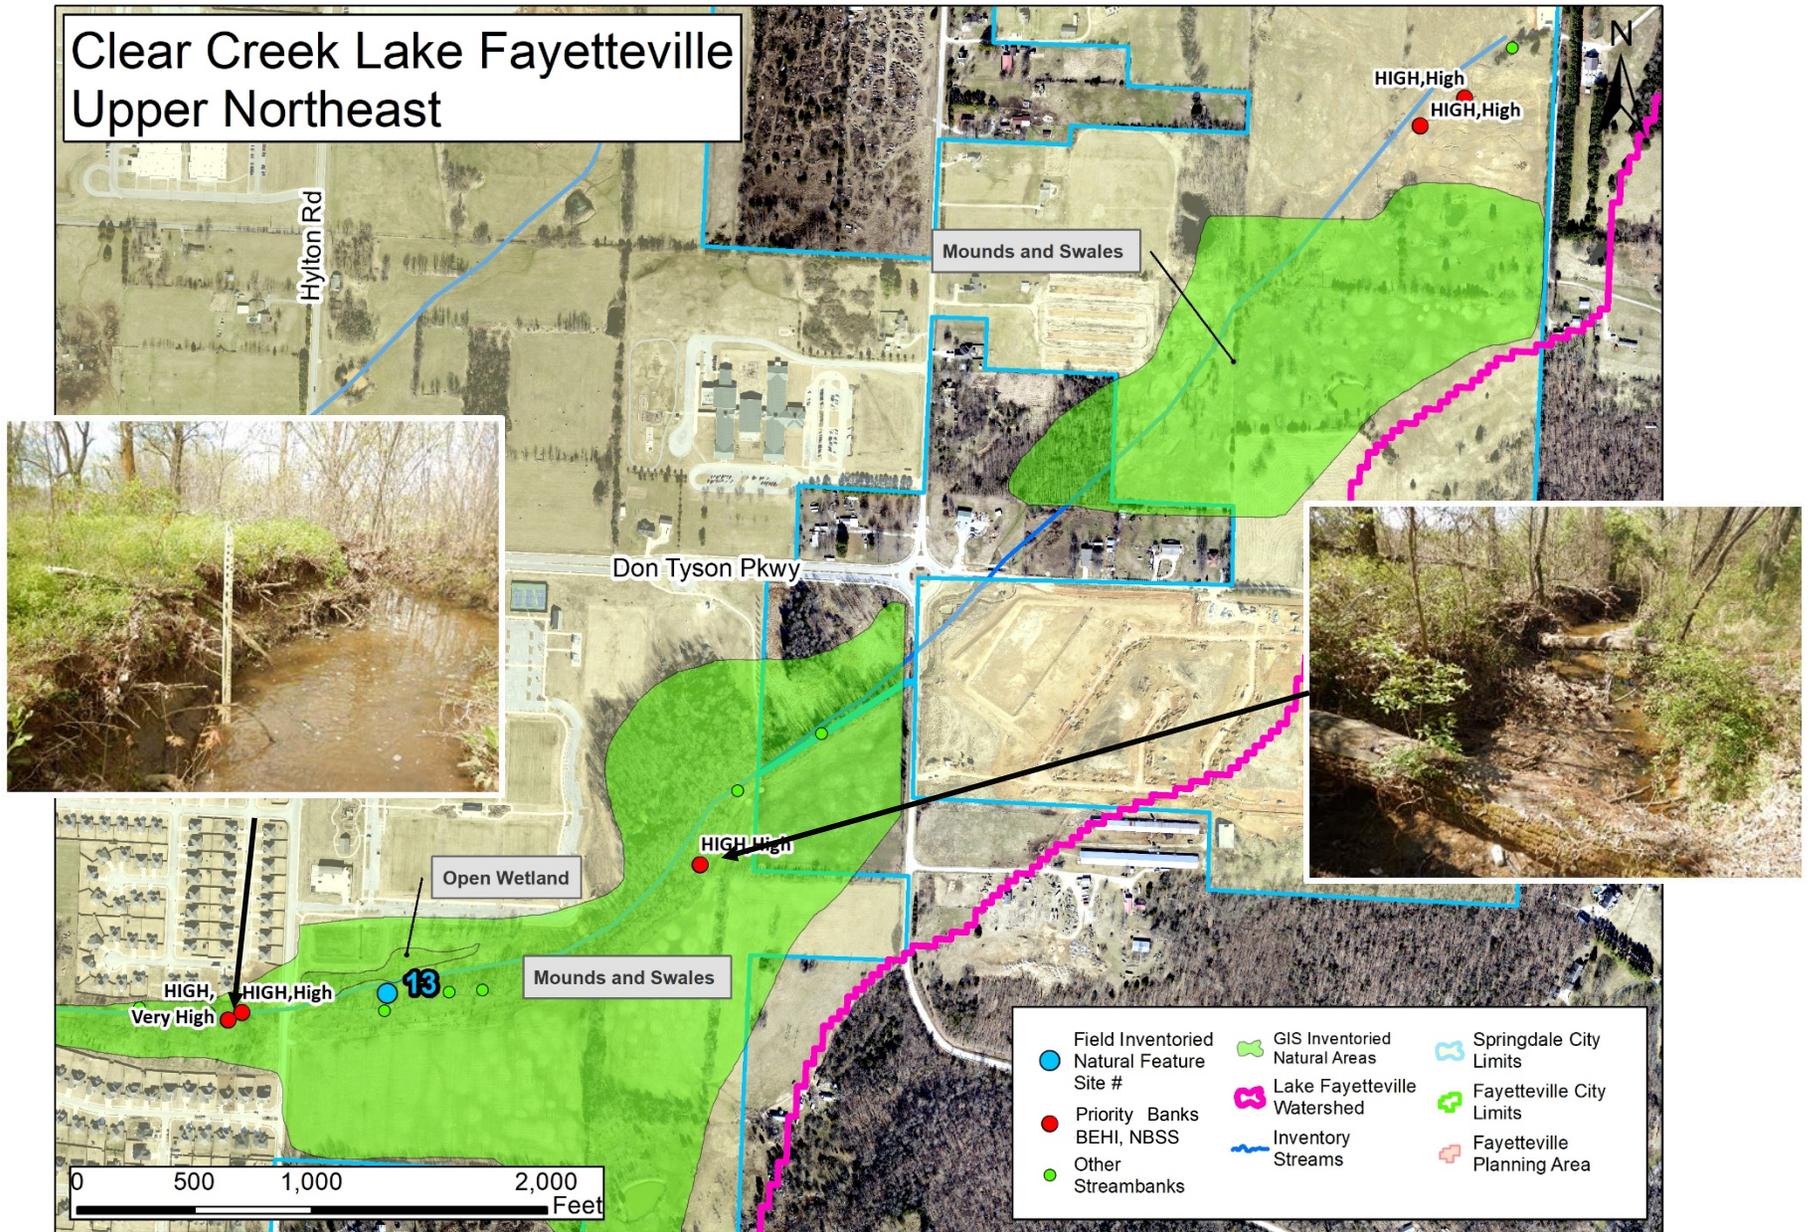
Figure 6-5. Lake Fayetteville Watershed – Priority Sites for Restoration and/or Conservation in the Upper Northeast Portion of Clear Creek

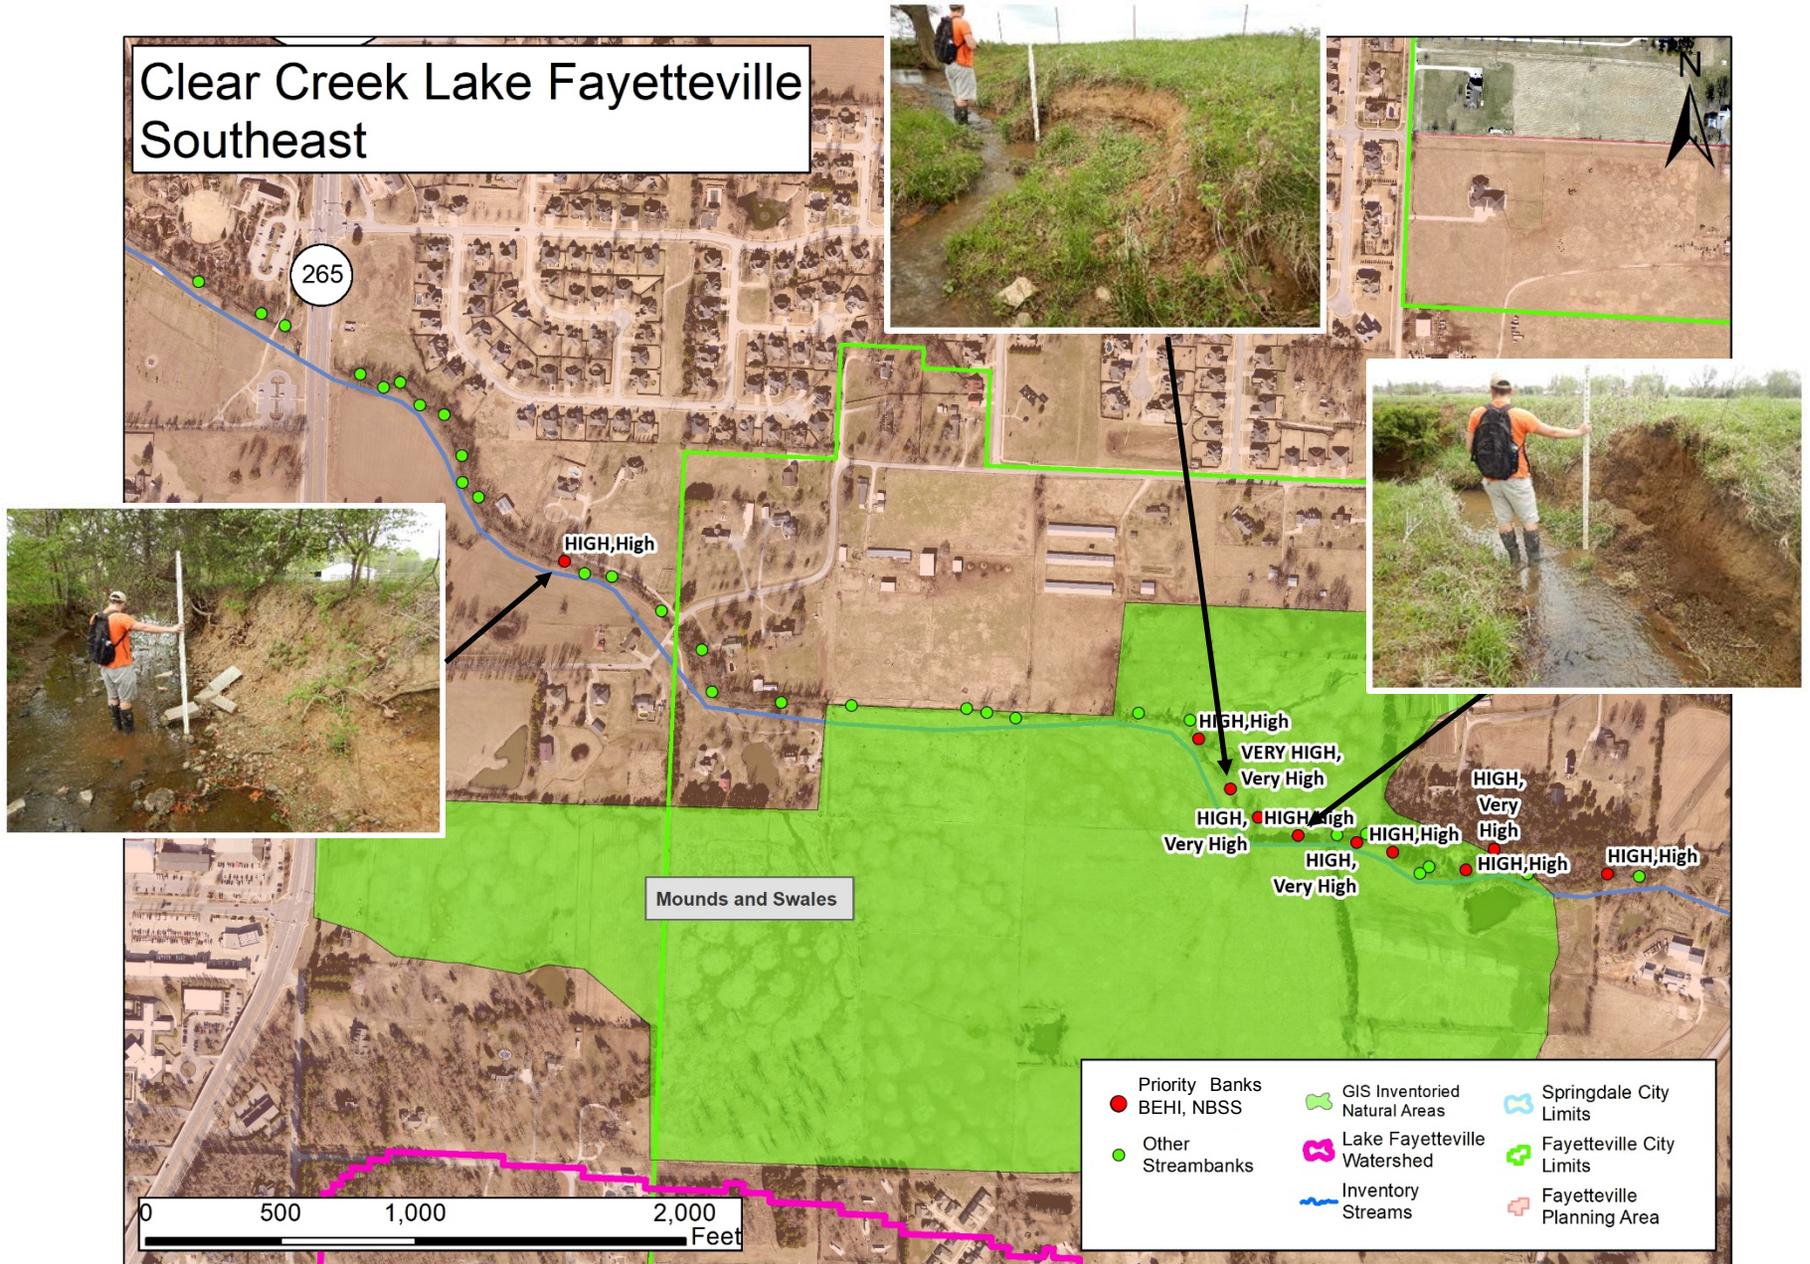
Figure 6-6 . Lake Fayetteville Watershed – Priority Sites for Restoration and/or Conservation in the Southeast Portion of Clear Creek
