City of Fayetteville Staff Review Form

SUBJECT: ANX 2020-000001: Annexation (3435 E. ZION RD./BURGE, 100/139):
Submitted by WATKINS LAW OFFICE for property located at 3435 E. ZION RD.
The property is in the FAYETTEVILLE PLANNING AREA and contains
approximately 59.00 acres. The request is to annex the property into the City Limits
of Fayetteville with the zoning of R-A, RESIDENTIAL AGRICULTURE.

The USDA Natural Resource Conservation Service (NRCS) awarded the Watershed Conservation Resource Center (WCRC) a grant to conduct an inventory of the riparian and streambank conditions for 20 miles of Clear Creek and select tributaries. The inventory included the main stem of Clear Creek and the tributaries above the Lake Fayetteville dam and the Skull Creek tributary. A map of the entire project area is shown in Figure 1-1. The project objectives were to:

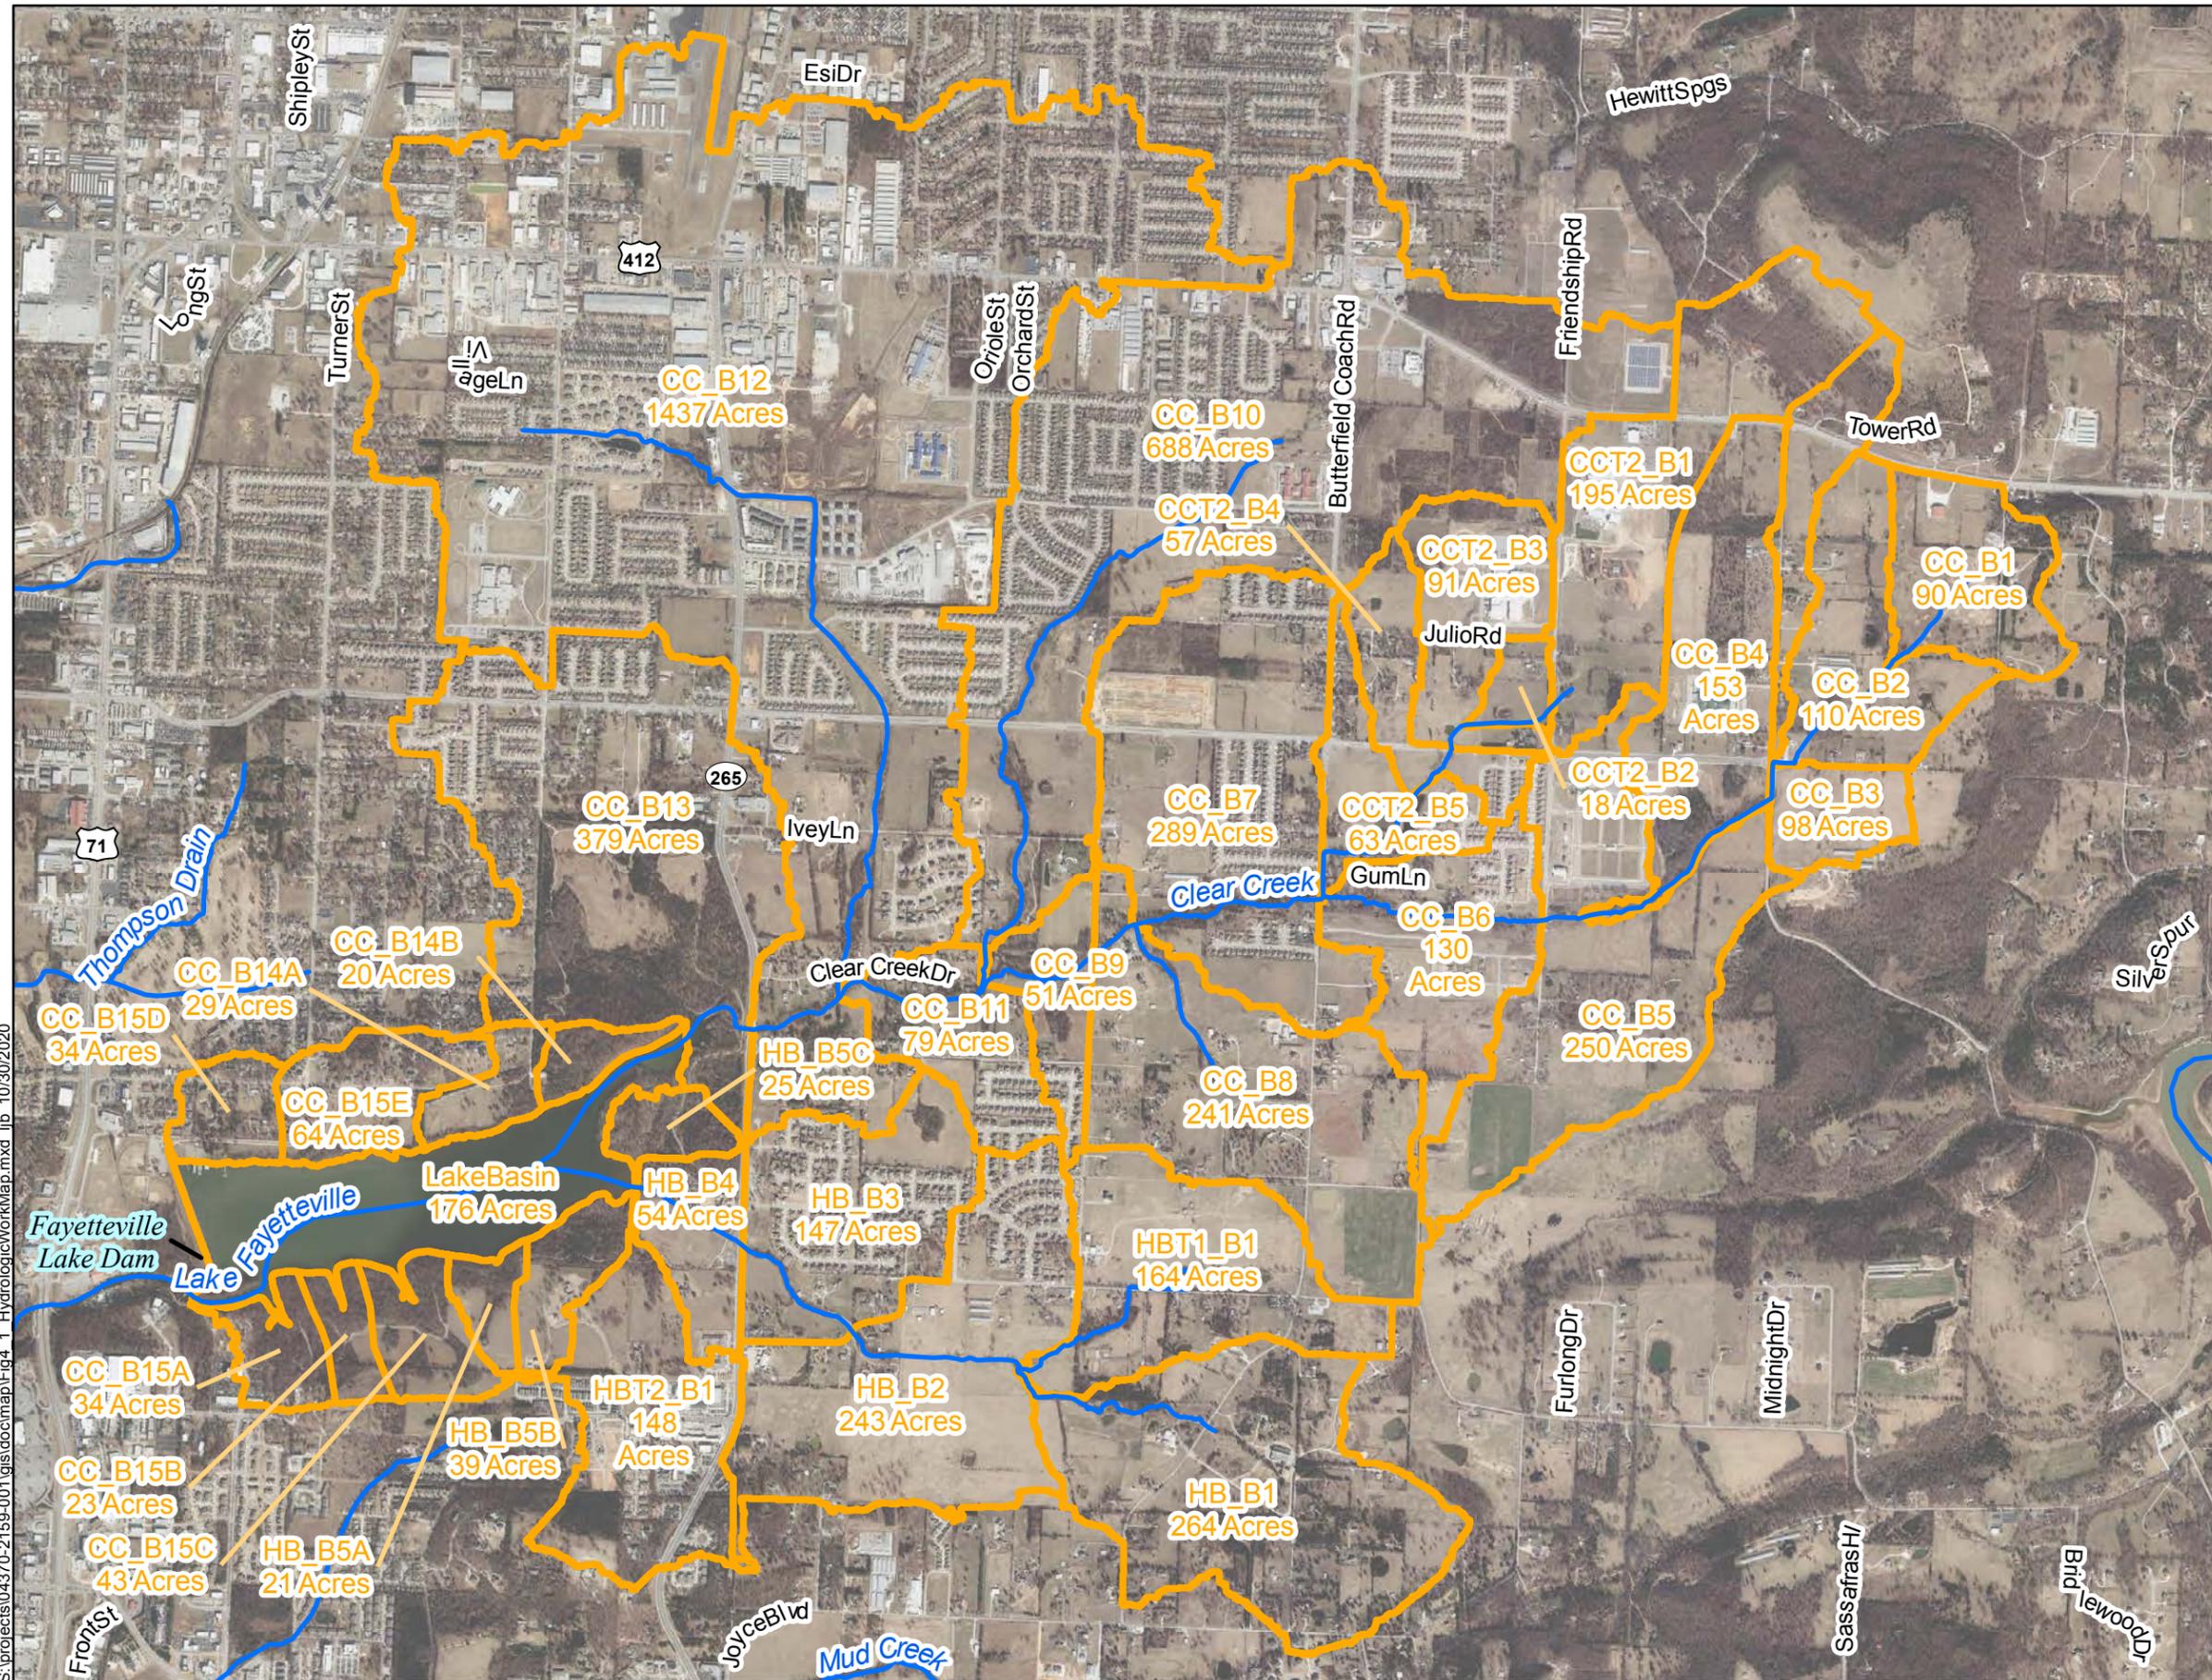
S:\projects\04370-2159-001\gis\doc\map\Fig4_1_HydrologicWorkMap.mxd jlb 10/30/2020

With the Arkansas CTP study as the base information, FTN used ESRI's ArcGIS (Version 10.5.1) software and tools to delineate the remaining watershed area down to the Lake Fayetteville spillway. The additional area was broken down based on a combination of factors, including drainage area, roadway crossings, and confluences with tributaries. Additionally, subbasins along the perimeter of Lake Fayetteville were further refined along with the lake itself being treated as its own subbasin in order to allow the contribution from direct precipitation onto the lake. All topographic data used for the new study is a combination of the 2015 Washington County LiDAR, available bathymetry data, and survey information where available. Figure 4.1 is a map showing various hydrologic features for the entire Project area.

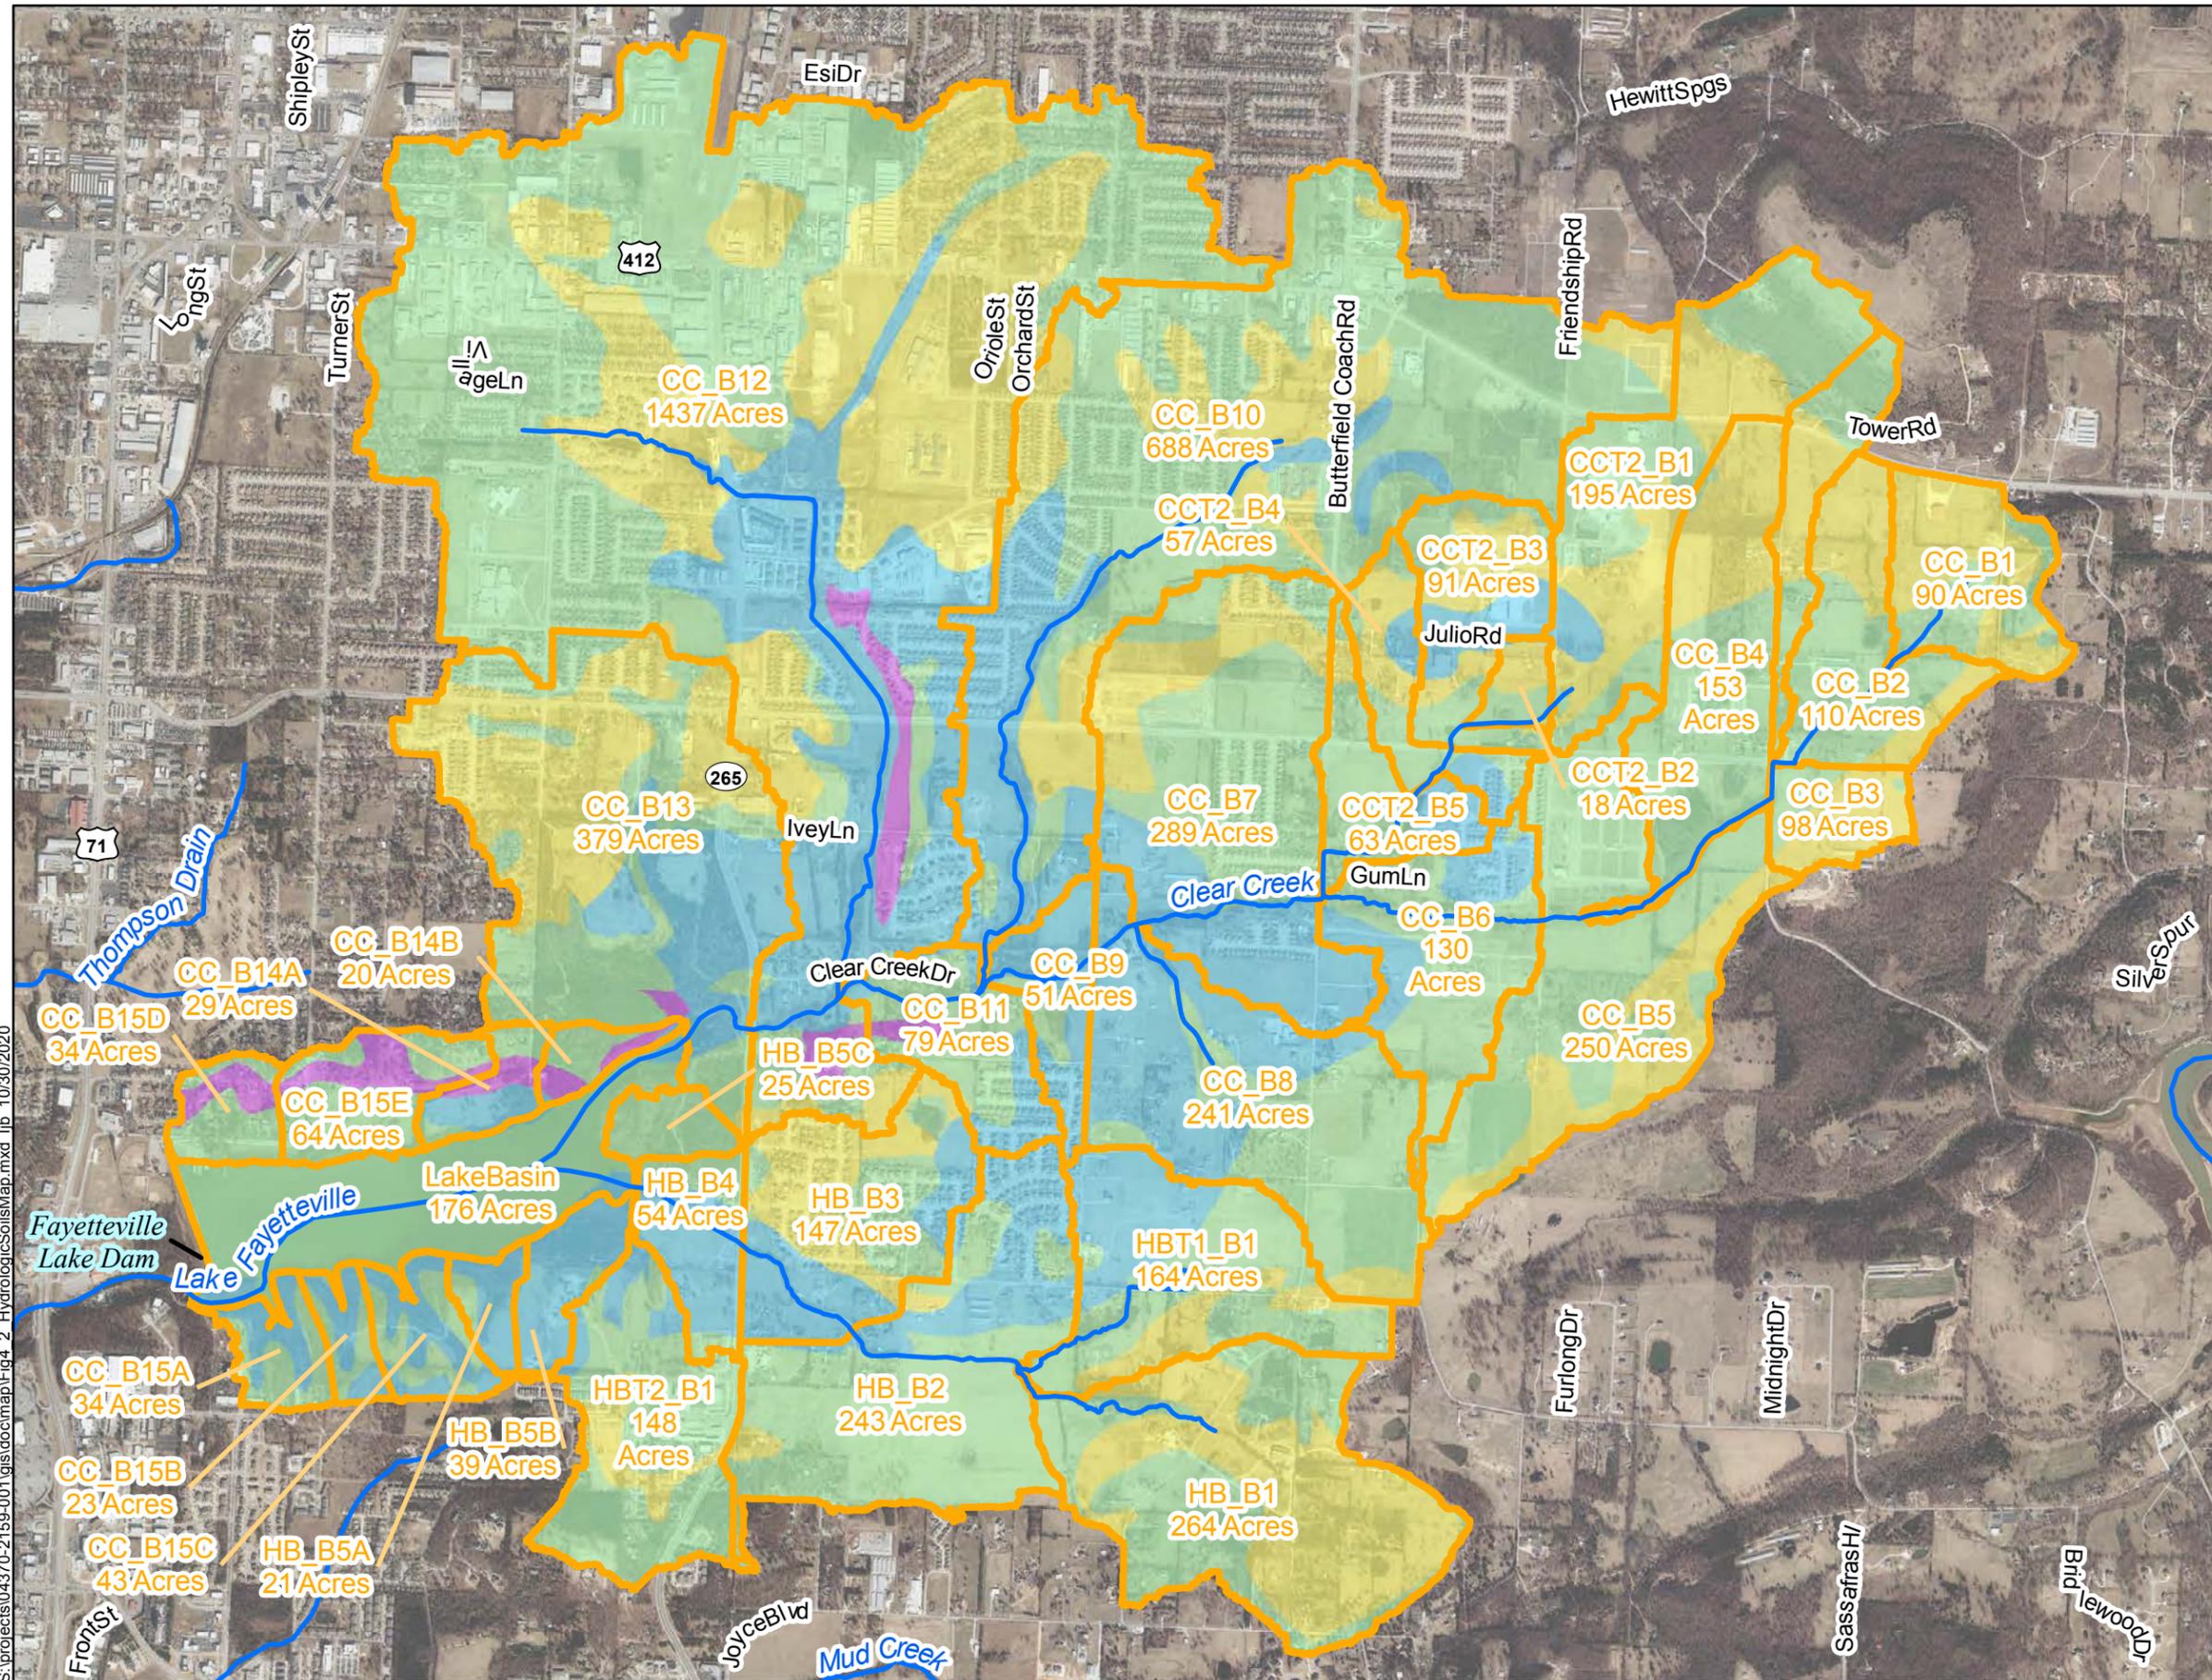
Figure 4.2
Lake Fayetteville Dam
Hydrologic Soils Map

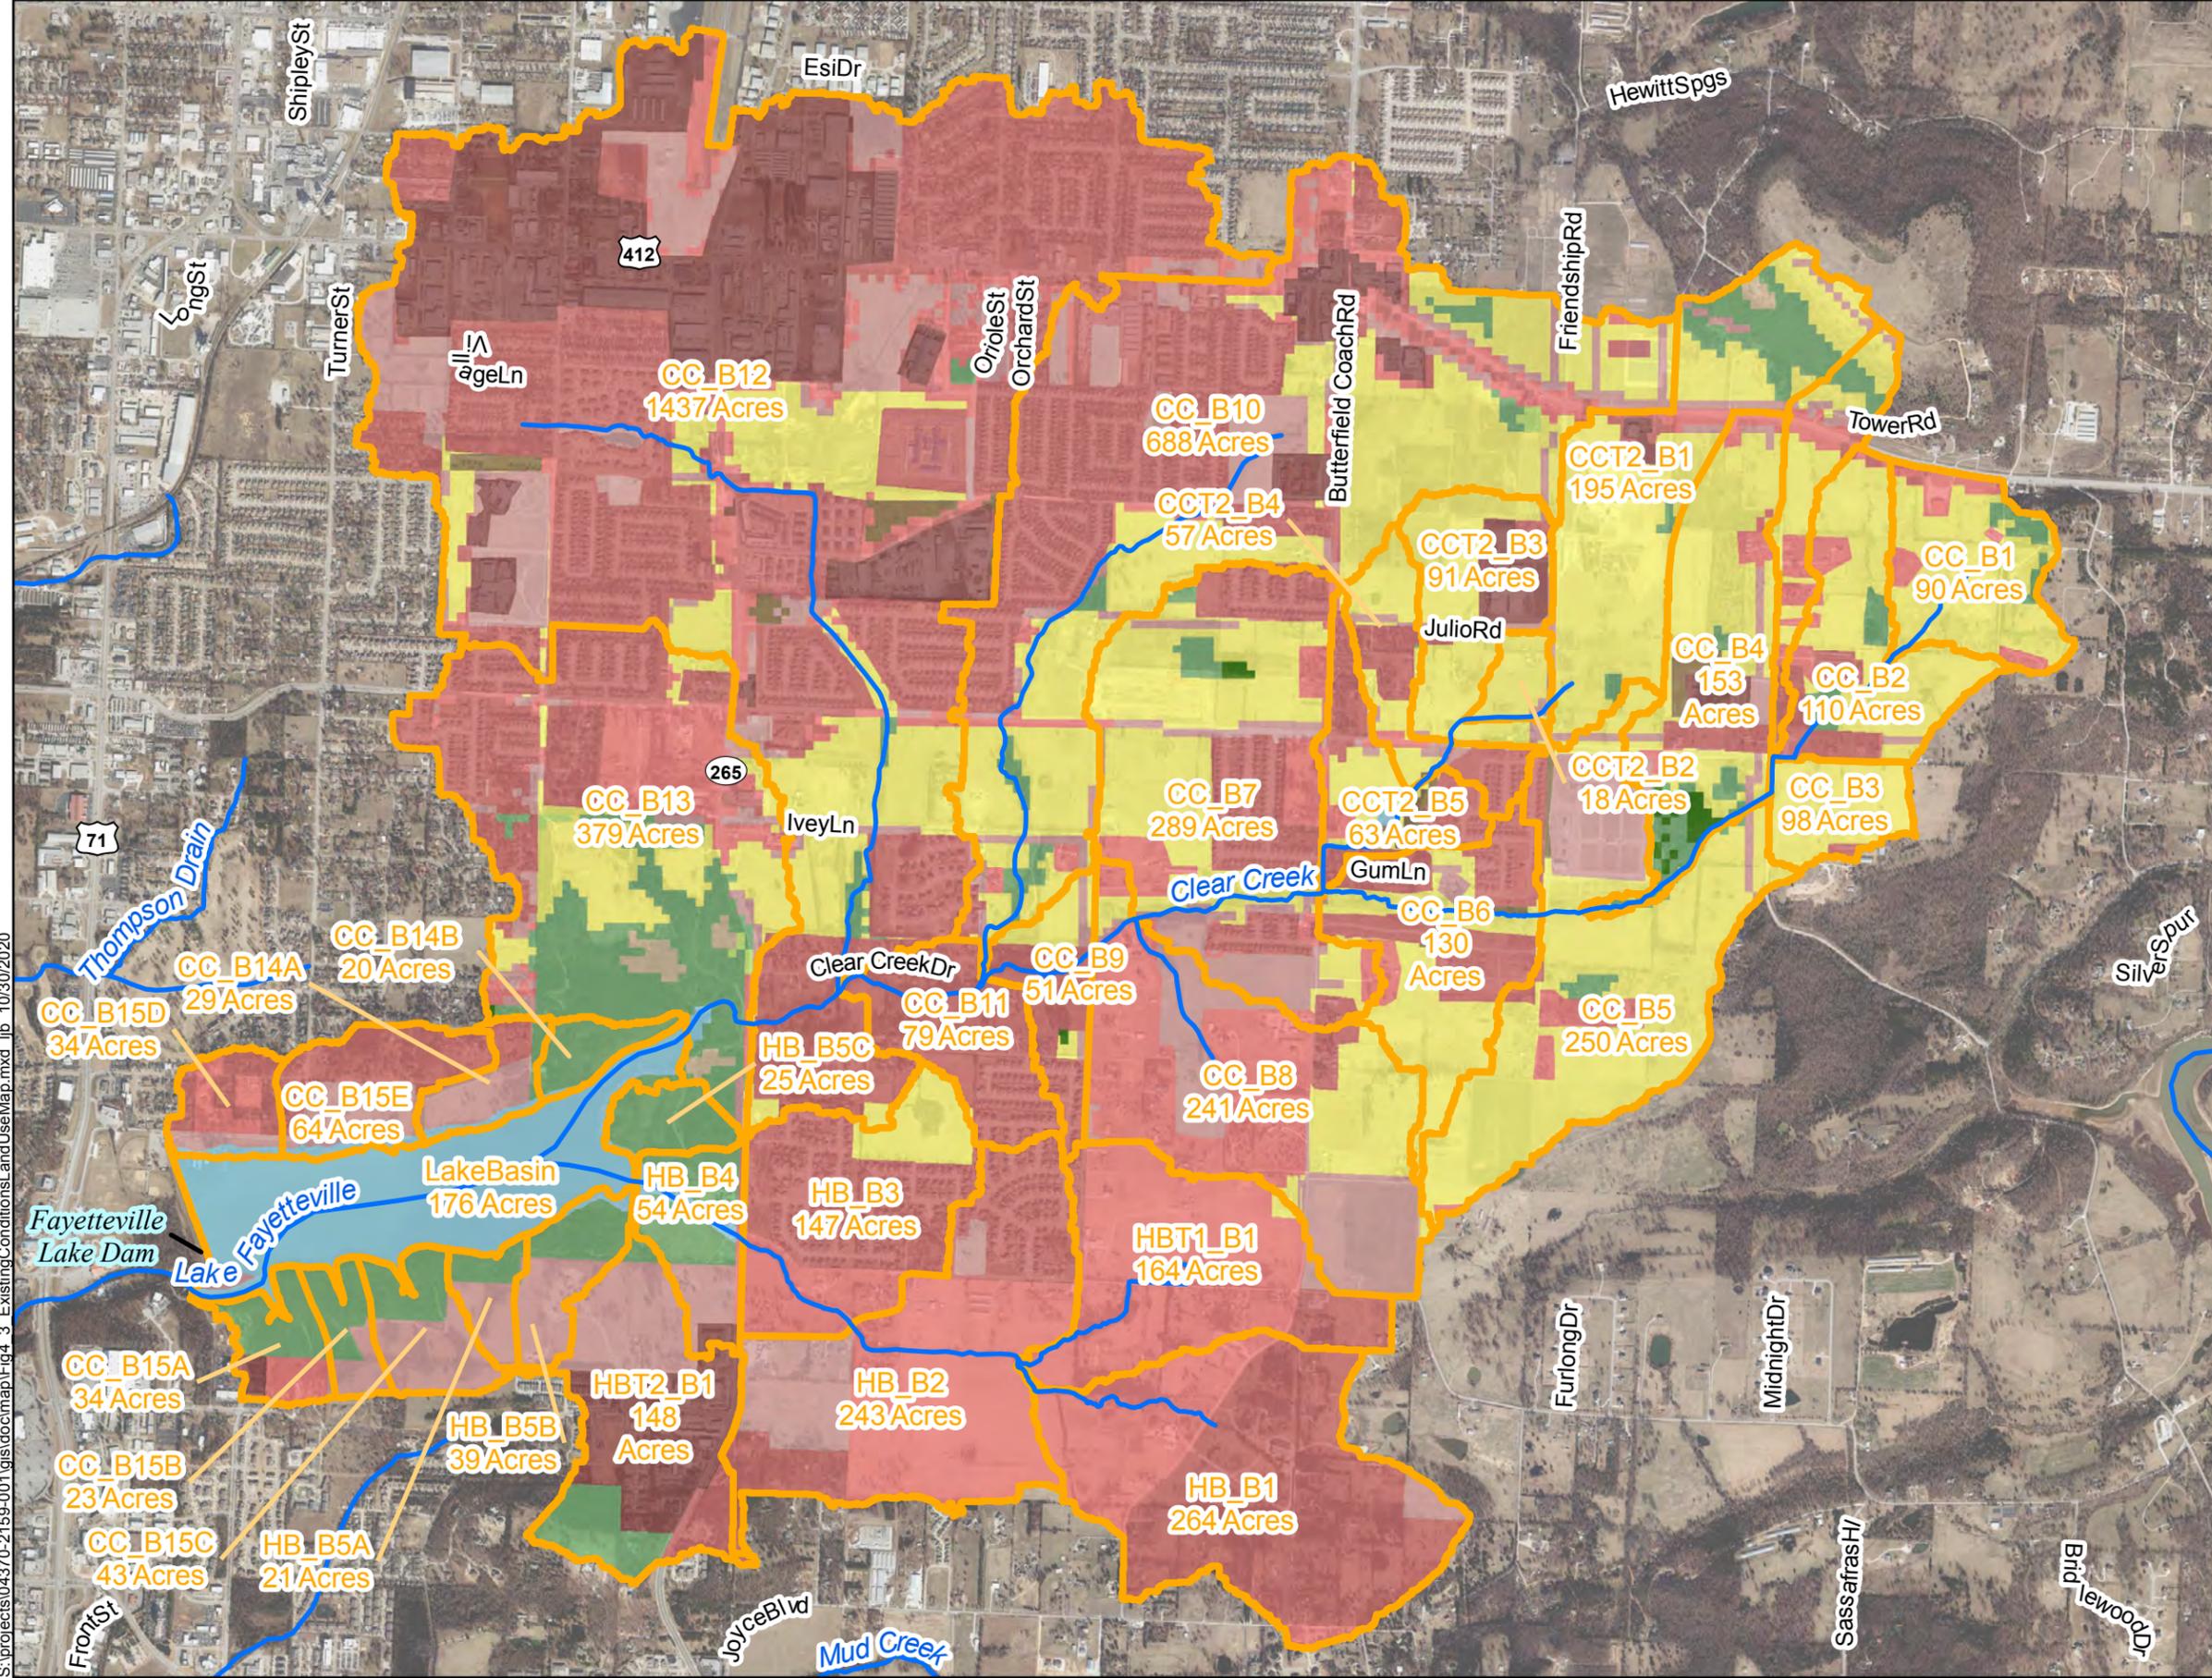
The current land use characteristics for the entire study area are displayed on Figure 4.3. Existing Conditions Land Use Map.

Figure 4.3
Lake Fayetteville Dam
Existing Conditions
Land Use Map

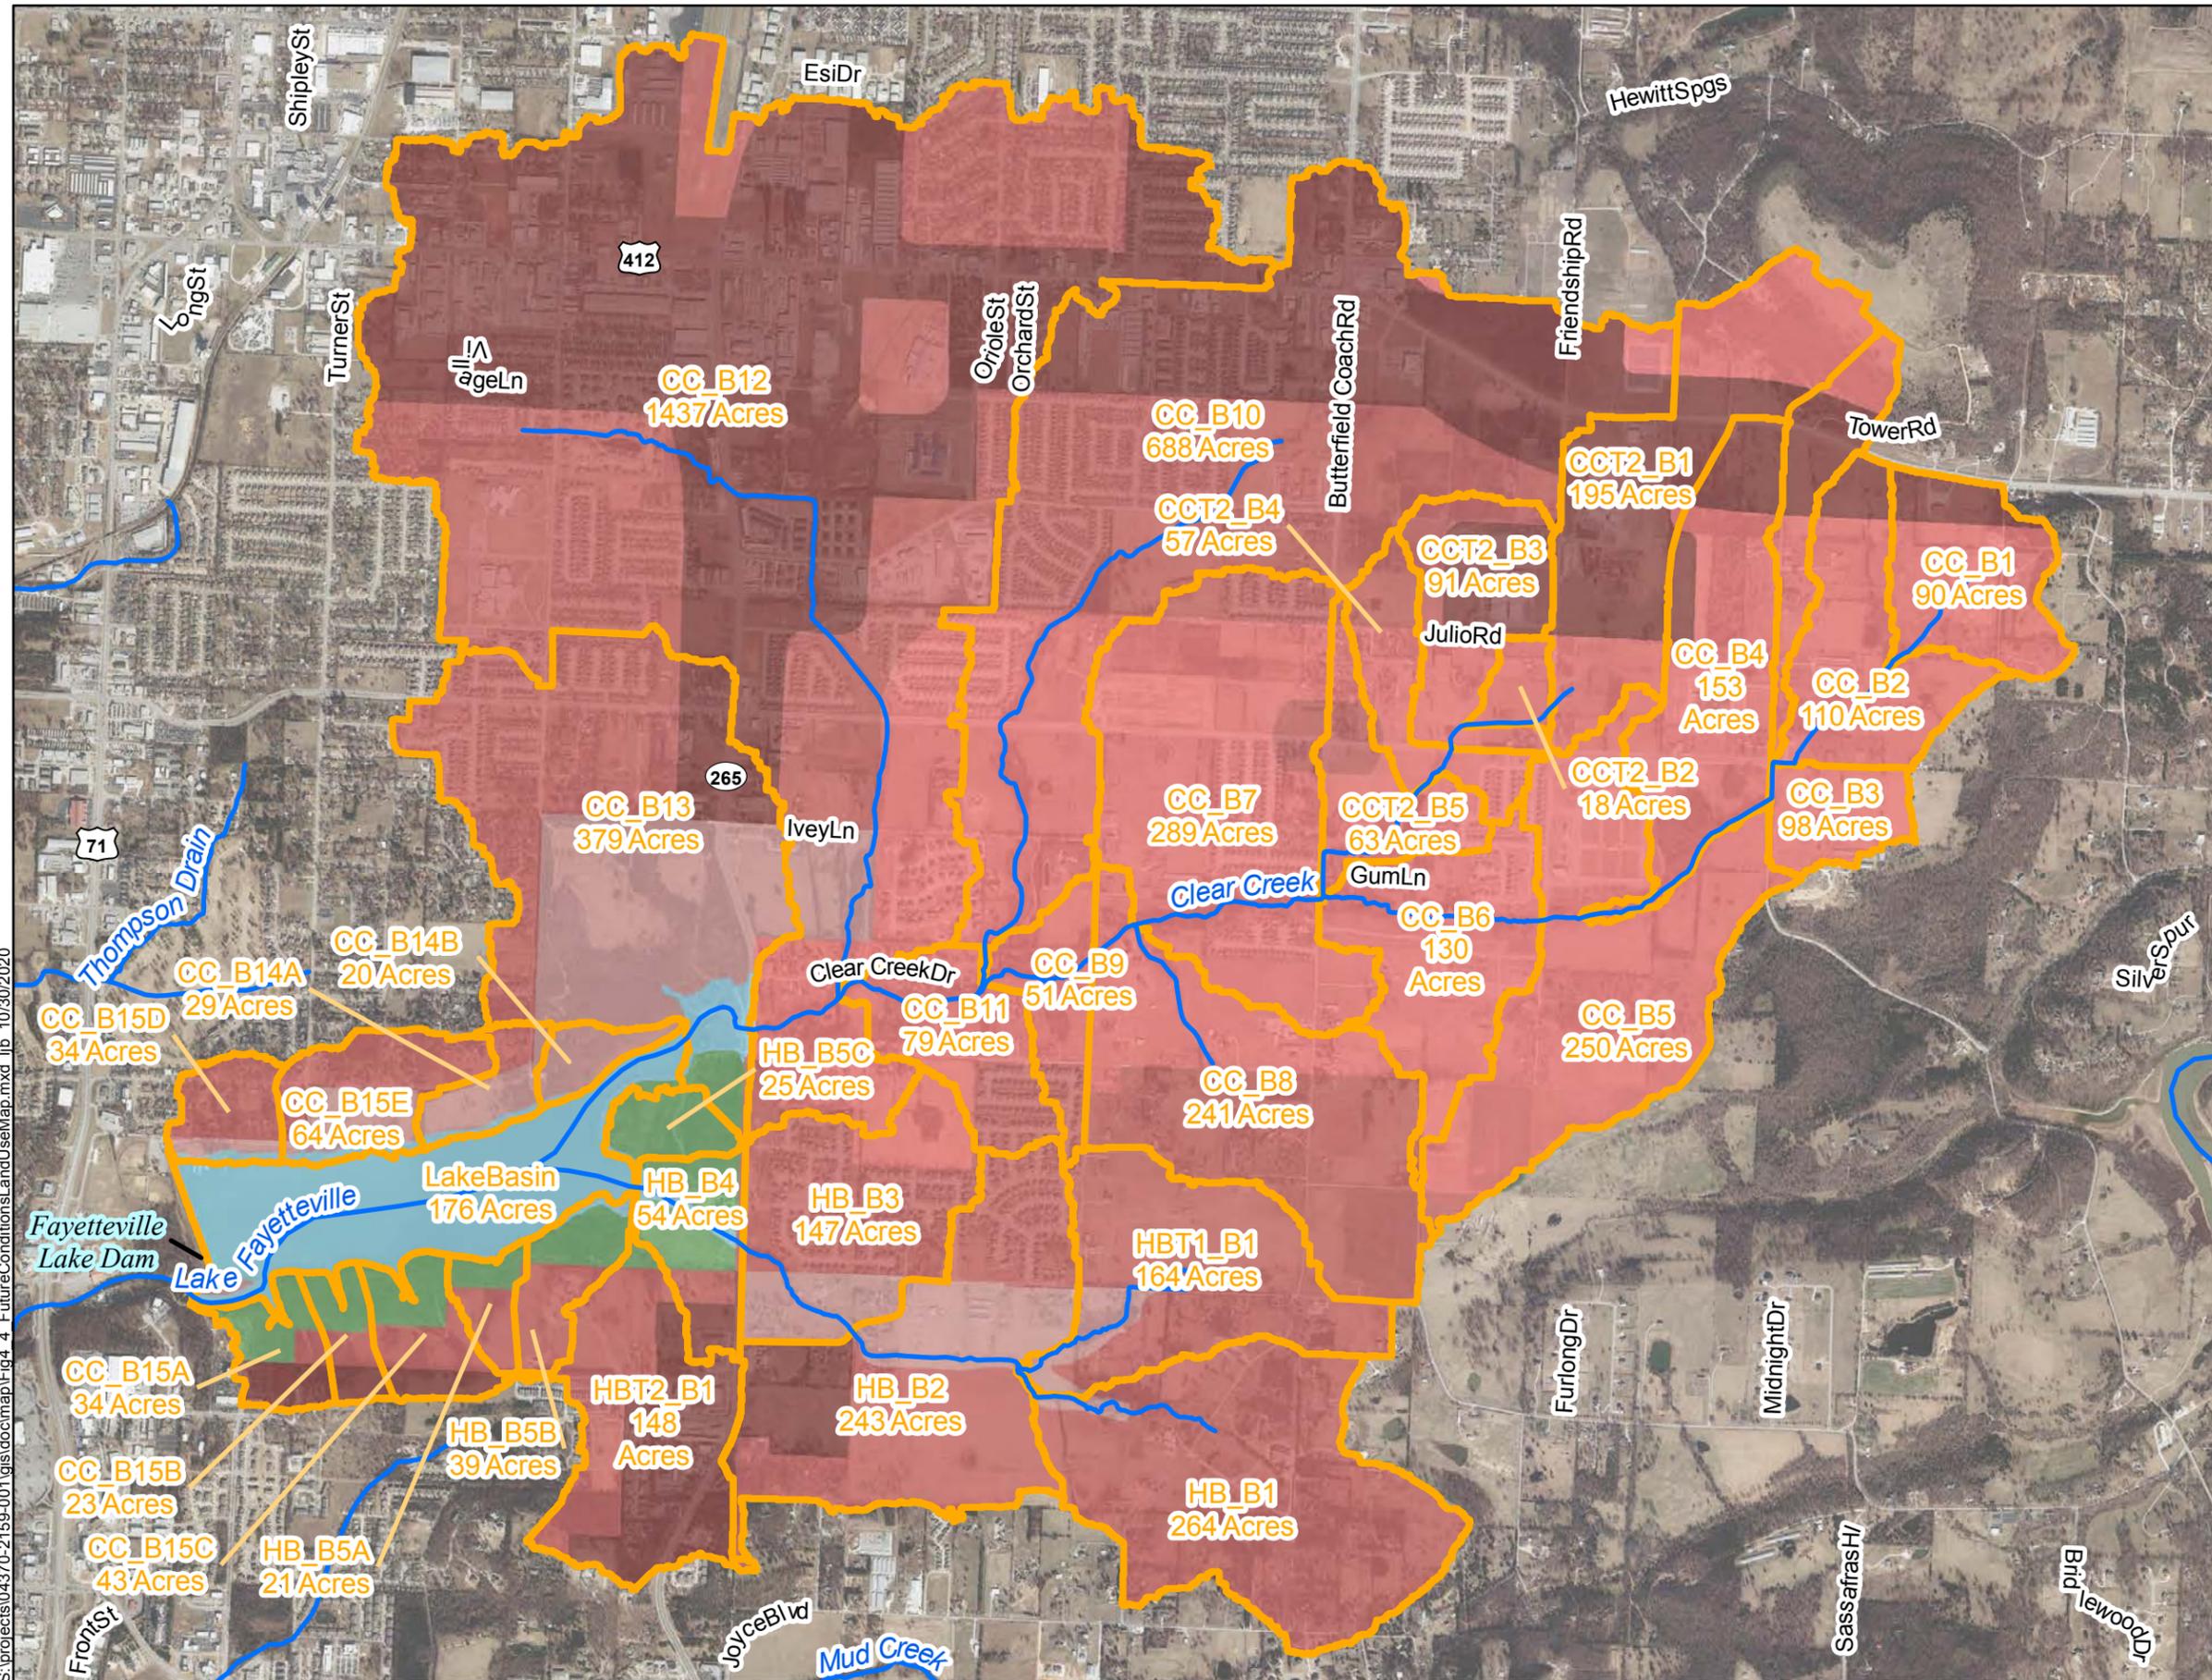
The projected land use characteristics for the entire study area are displayed on Figure 4.4. Future Conditions Land Use Map. Table 4.2 Subbasin hydrologic parameter summary is a tabular summary of the subbasin parameters used in the hydrologic analyses.

Figure 4.4
Lake Fayetteville Dam
Future Conditions
Land Use Map

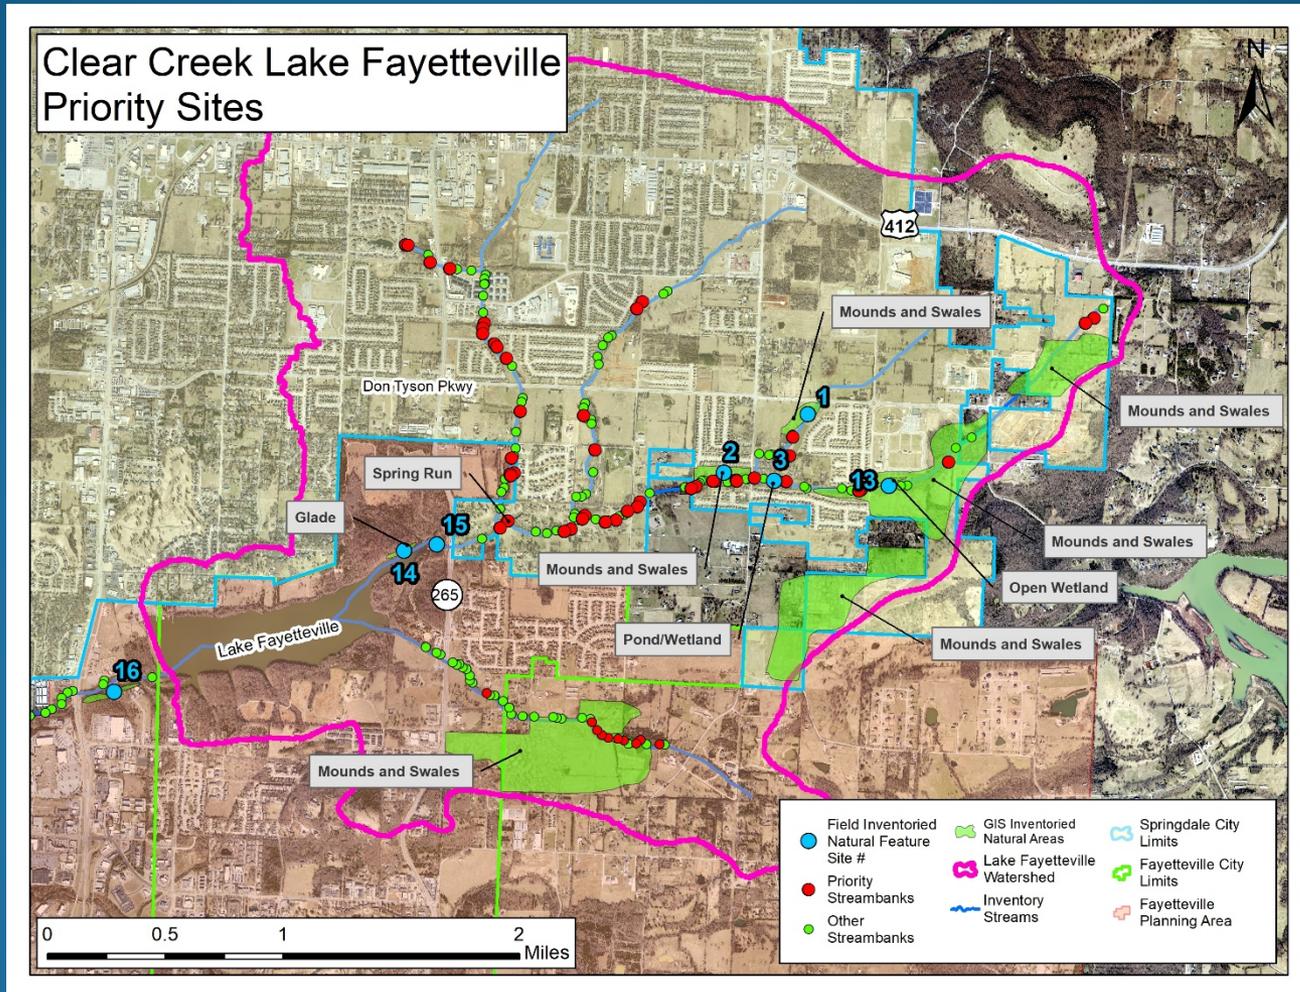
Priority Streambank– Both BEHI and NBSS are defined as High, Very High or Extreme, and if NBSS is Very High or Extreme
